# Nantucket Navigational Structures—Information Sheet

New England District, US Army Corps of Engineers

8 January 2013

## Nantucket Jetty Conditions Reports –2012

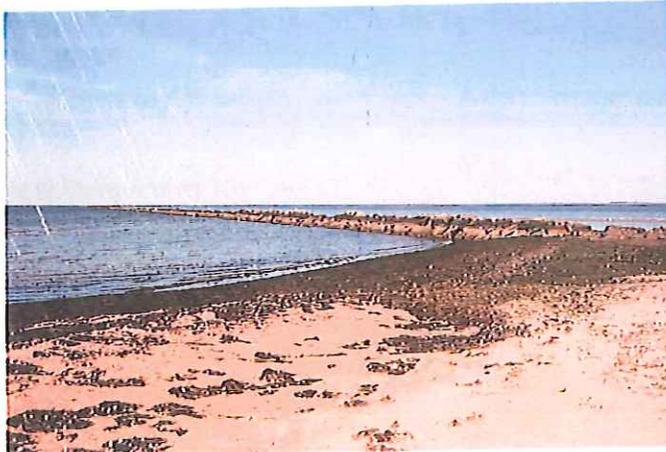
Photo 7—West Jetty Crown displacement / degradation.

West Jetty — 4,600 CY of 2 to 2 1/2 ton stone size

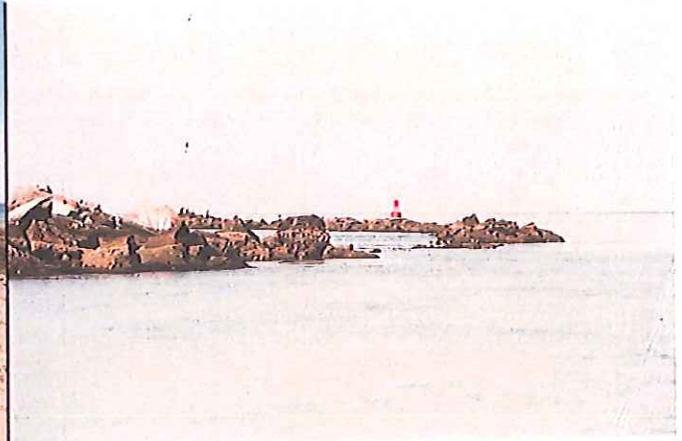
Photo 8—Armor stone displacement and Breakwater voids at Low Tide.

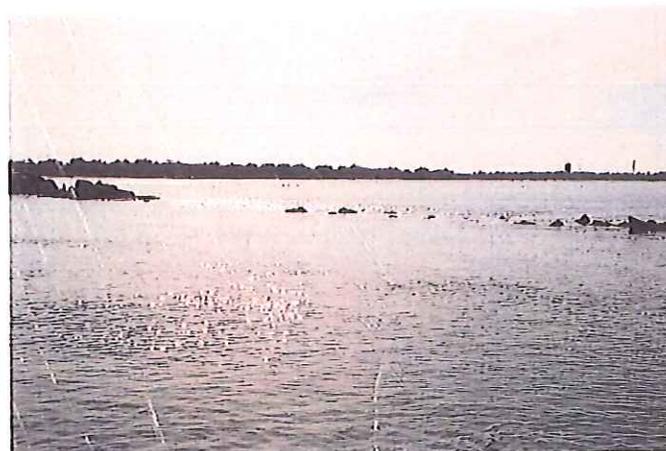
Photo 9—Armor stone displacement and Crown elevation loss shown at Mid-Tide.

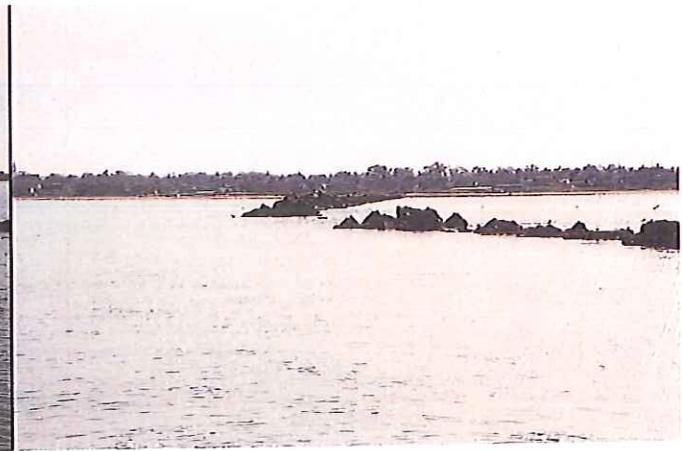
Photo 10—Breakwater Core exposure and erosion; loss of armor stone units.

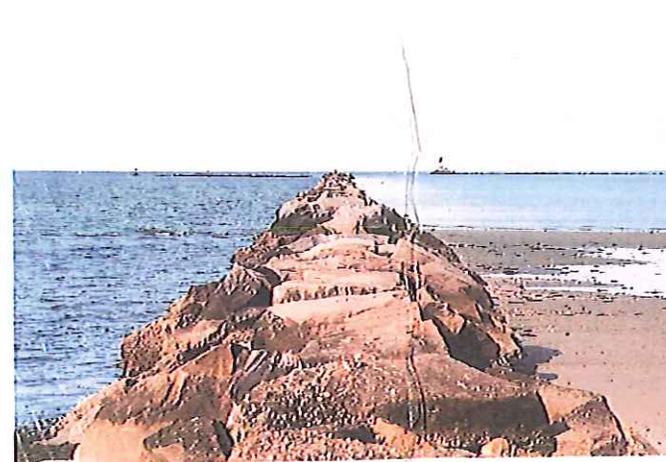
Photo 11—Wave protection for Navigation channel in light wind.

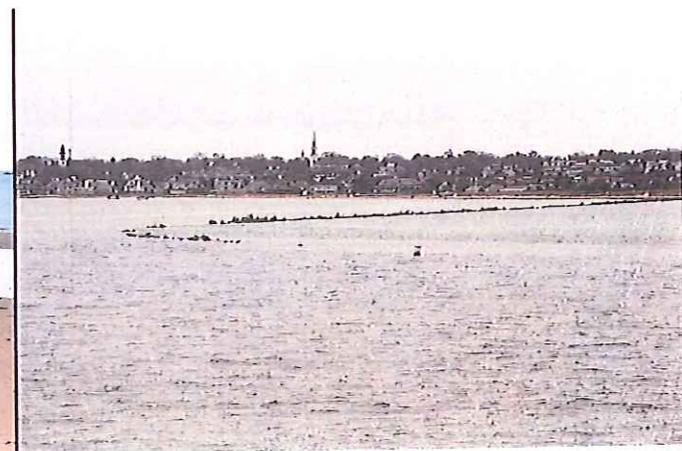
Photo 12—West Jetty wave overtopping in light winds during Low Tide.

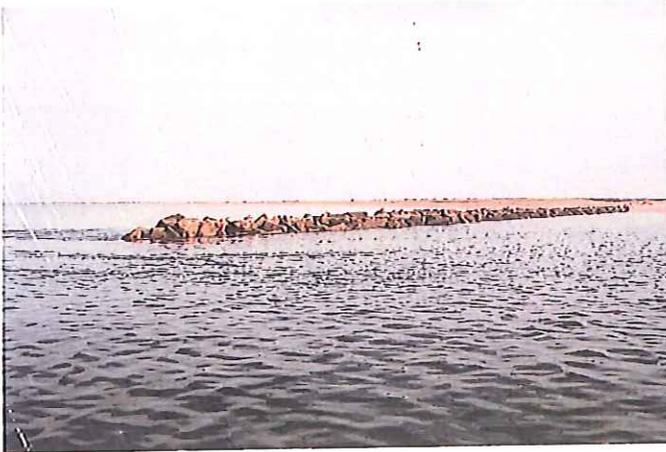
Photo 1— Full Cross Section during Mid-Tide

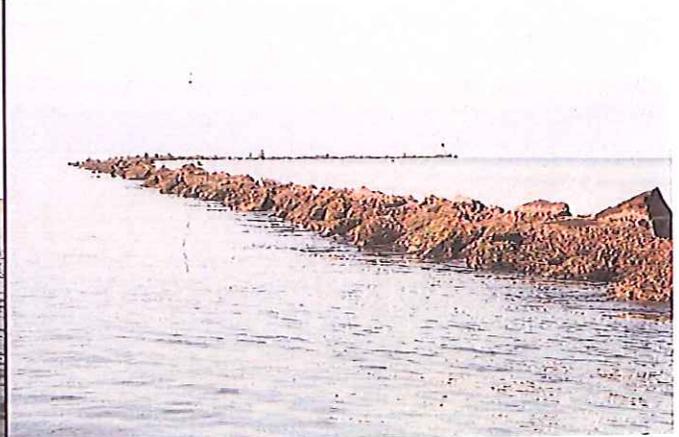
Photo 2— Half Tide Cross Section at Low Tide

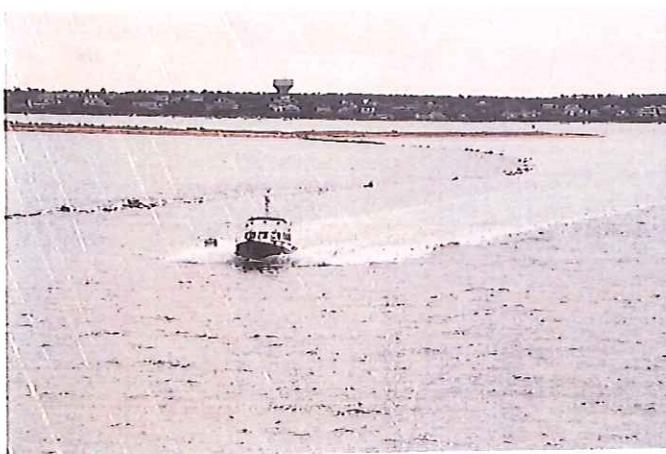
Photo 3—Vessel passing during High Tide.

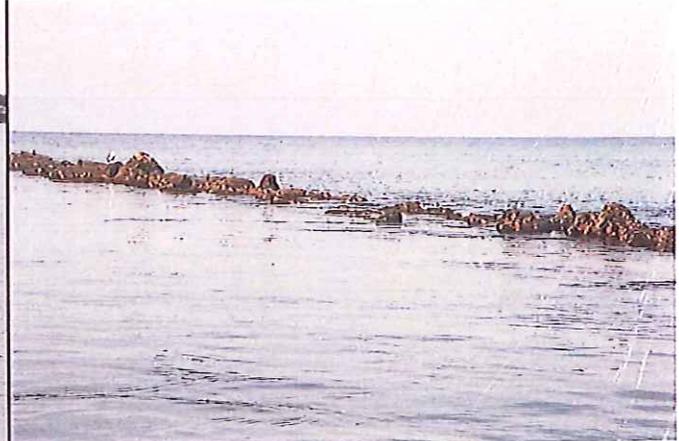
Structure Name	Inspection Rating (1-5)	Structural Condition Rating (SCB) (A-F)	Functional Condition Rating (FCR) (A-F)	District Conditional Rating (DCR)	Economic Impact / Consequence Category	Description of Damage
East Jetty	4—Serious	D—Seriously Degraded	C—Moderate Functionality	D—Seriously Degraded	II	Multiple displaced armor stones creating many large breaches throughout the length of the structure. Deterioration is noted over a significant portion of the structure. Some areas of the structure have settled, collapsed or eroded to an extent that, in the damaged area, no portion of the crest is still located at the original elevation.
West Jetty	4—Serious	D— Seriously Degraded	B—Adequate Functionality	C— Moderately Degraded	II	Multiple displaced armor stones creating many large breaches in certain portions of the structure. The geometry of the structure is showing significant change in some areas. Some of the structure may have settled, collapsed, or eroded to an extent that other portions of the structure are exposed or left unsupported.

Photo 4— Voids in East Jetty during Mid-Tide

East Jetty — 16,100 CY of 2 to 2 1/2 ton stone size

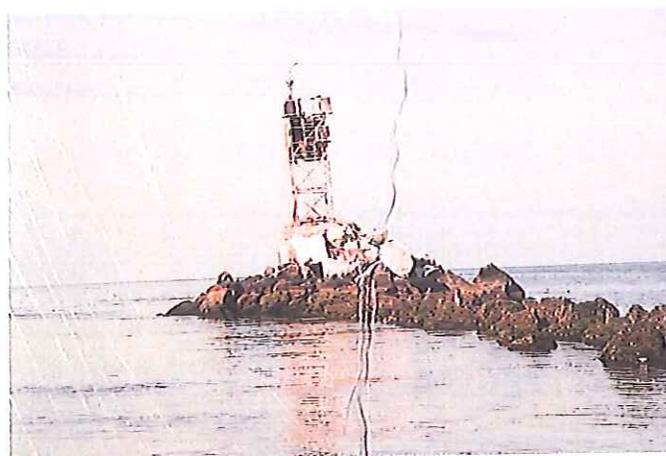
Photo 5— Channel Light at the end of East Jetty (structural disrepair).

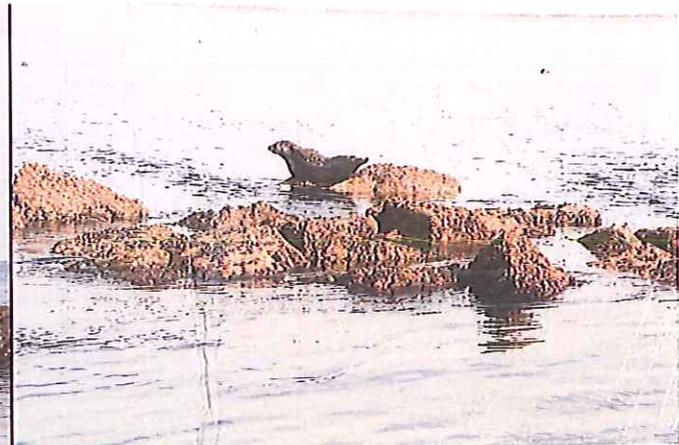
Photo 6— Displaced Armor stone due to wave activity.
