SBPF Site Inspection Report/Log

Inspector: Ali Tepsurkayev

Date: 04/20/20 Time: 9:19 am Weather: Cloudy 49°F

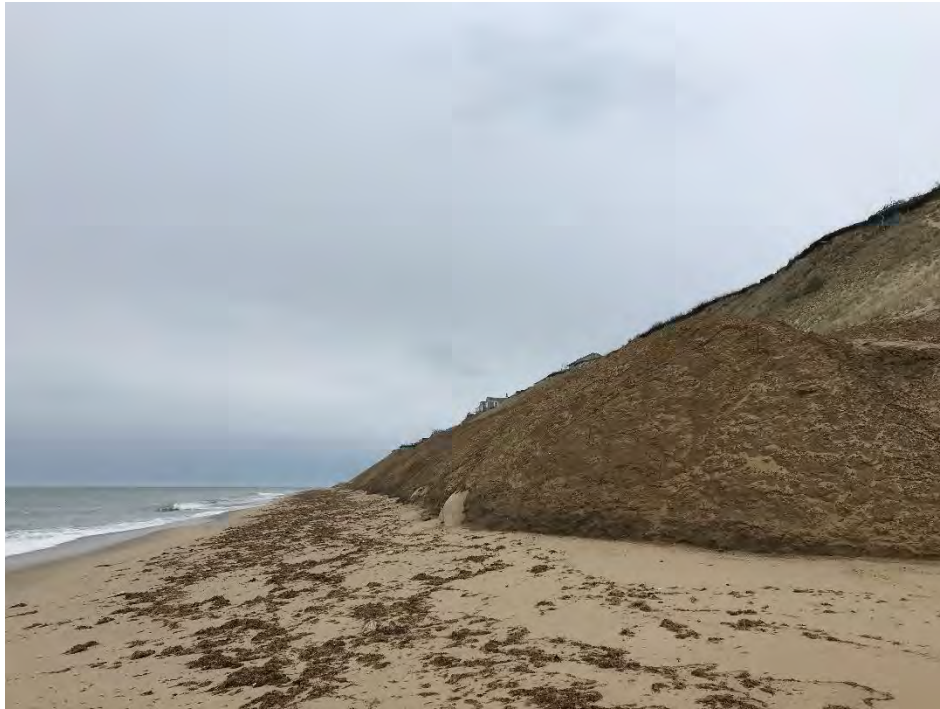
Approximately ~ 10 feet of 2nd GEO Tube exposed.

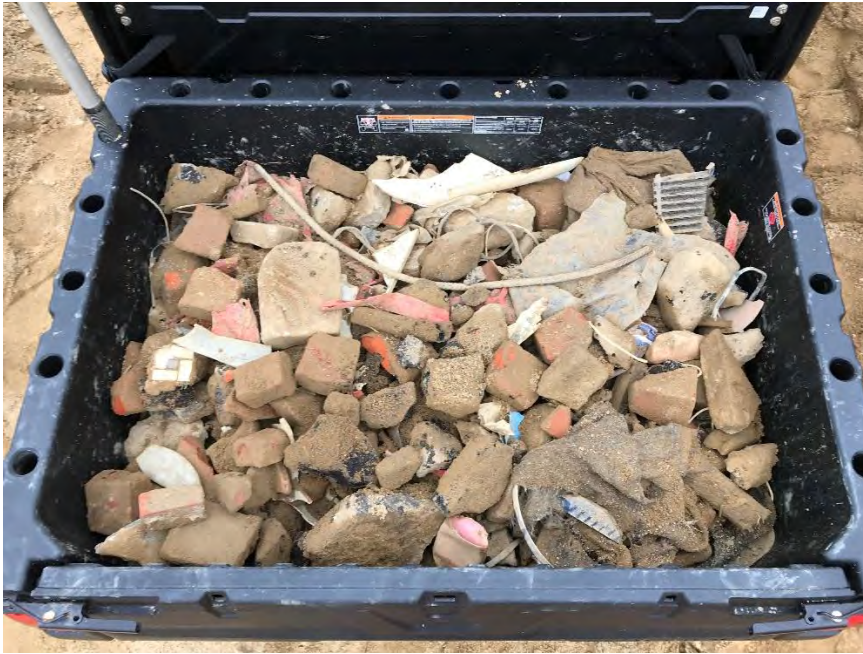
Approximately 4.5 cubic feet of debris such as bricks, concrete, PVC and electric wire were collected from delivery area during template grading.

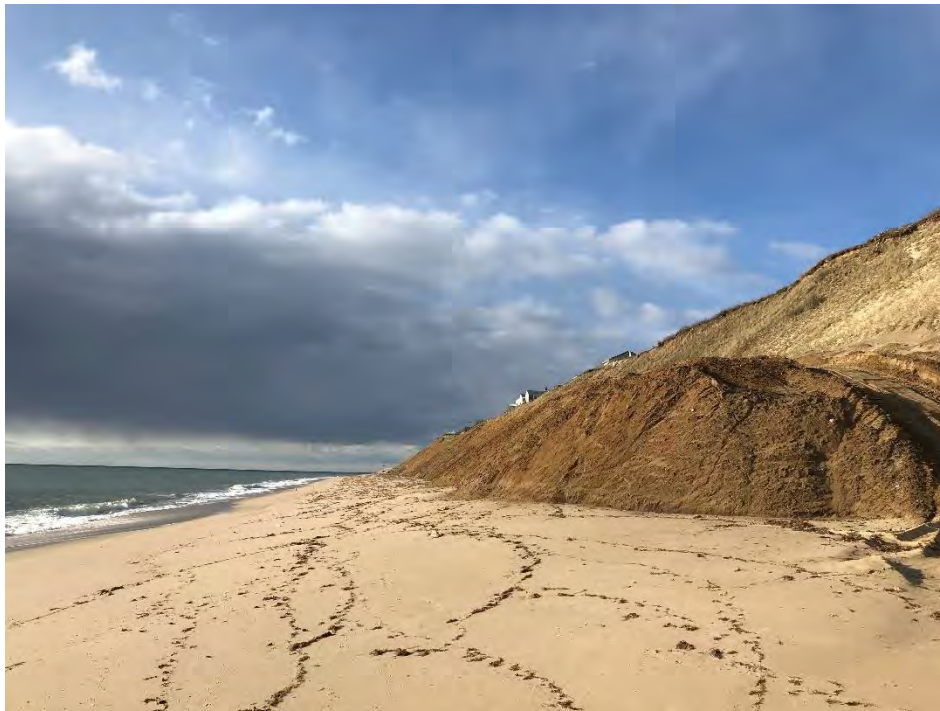
GEO tubes were covered during 04/20/2020 maintenance.

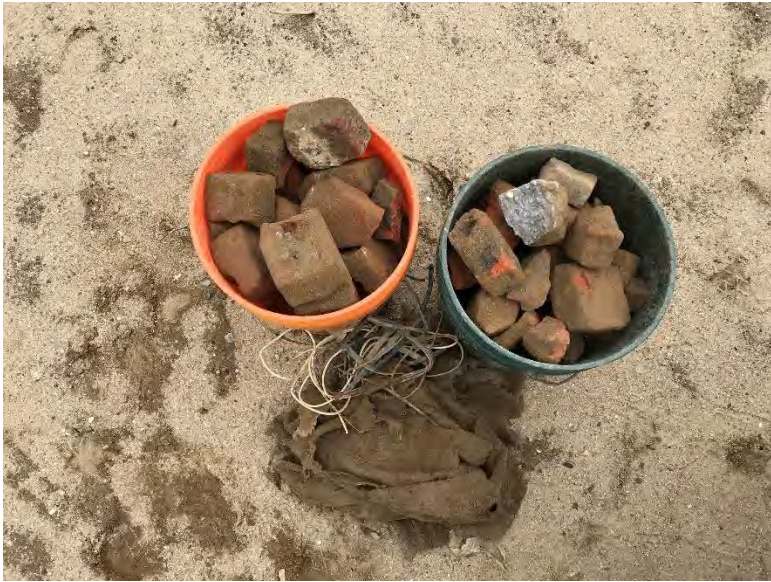
10gl. bricks, small amount of wire, few small concrete blocks and landscaping felt were collected during template grading at the delivery area

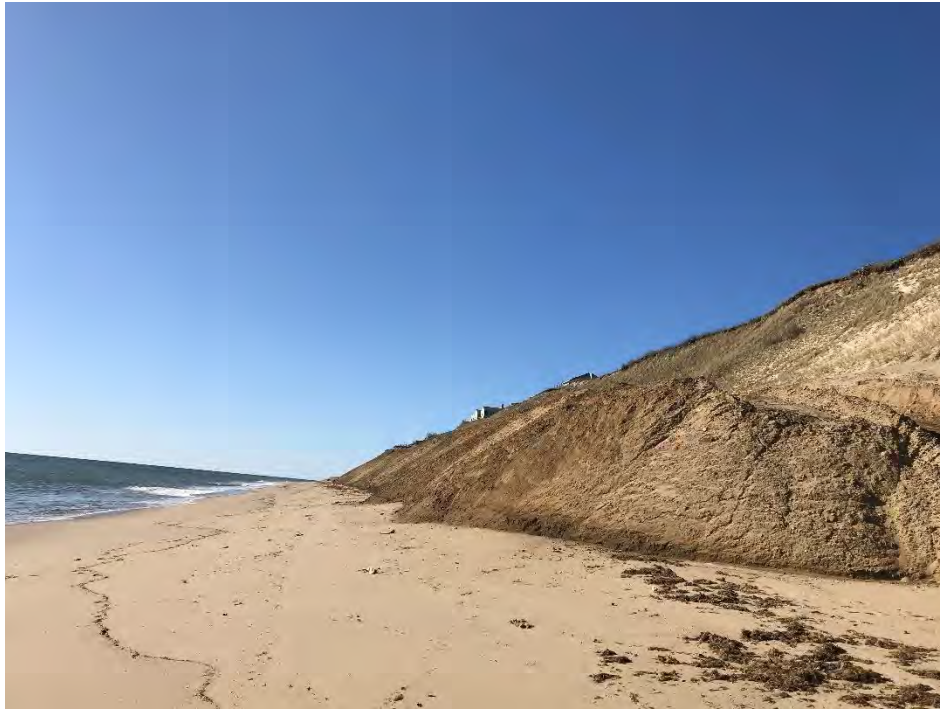
GEO tubes were covered during 04/20/2020 maintenance.

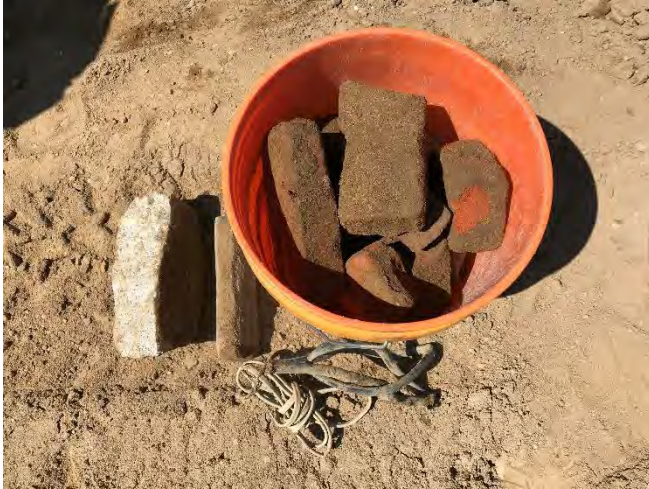
~ 5gl. bricks, small amount of wire and 2 concrete blocks were collected during template grading at the delivery area.

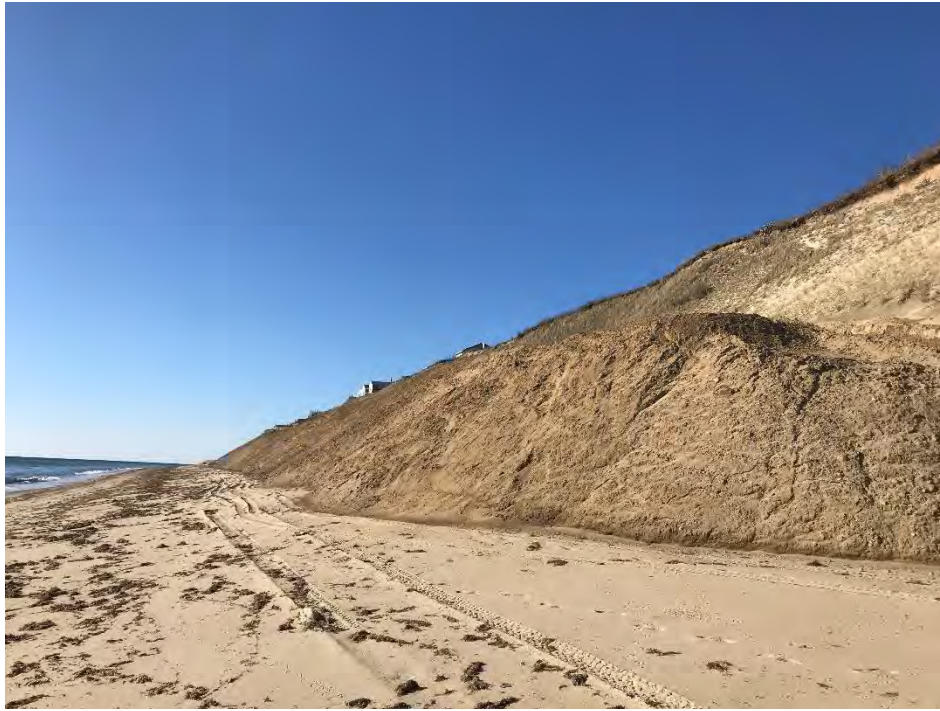
GEO tubes were covered during 04/20/2020 maintenance.

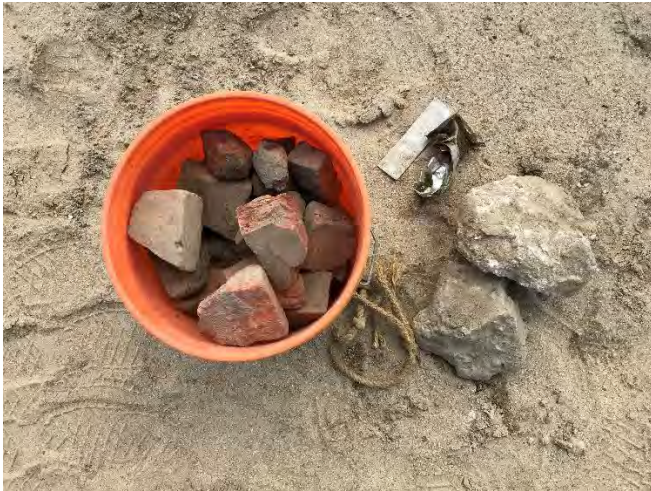
~ 5gl. bricks, small rope, 2 stainless still metal and few concrete blocks were collected during template grading at the delivery area.

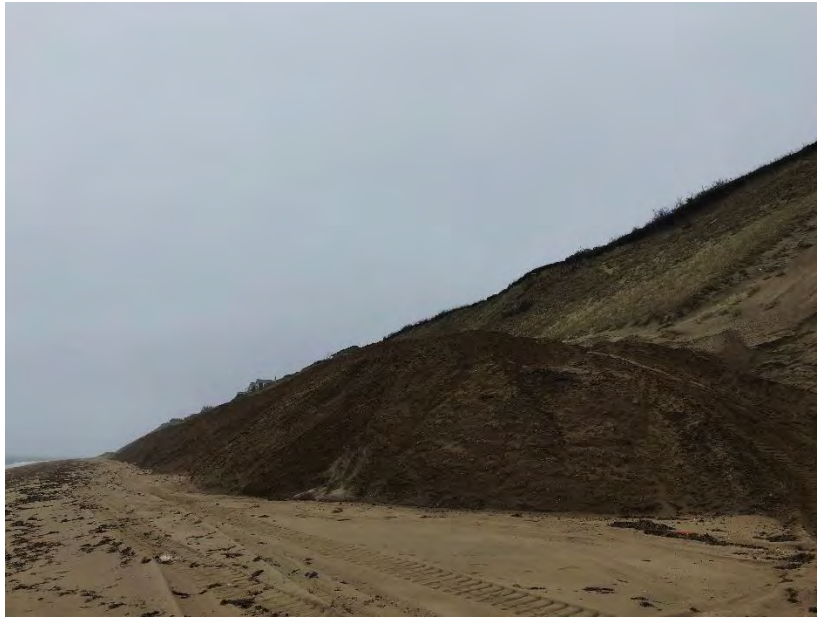
No exposed GEO tubes.
