2020

SBPF Site Inspection Report/Log

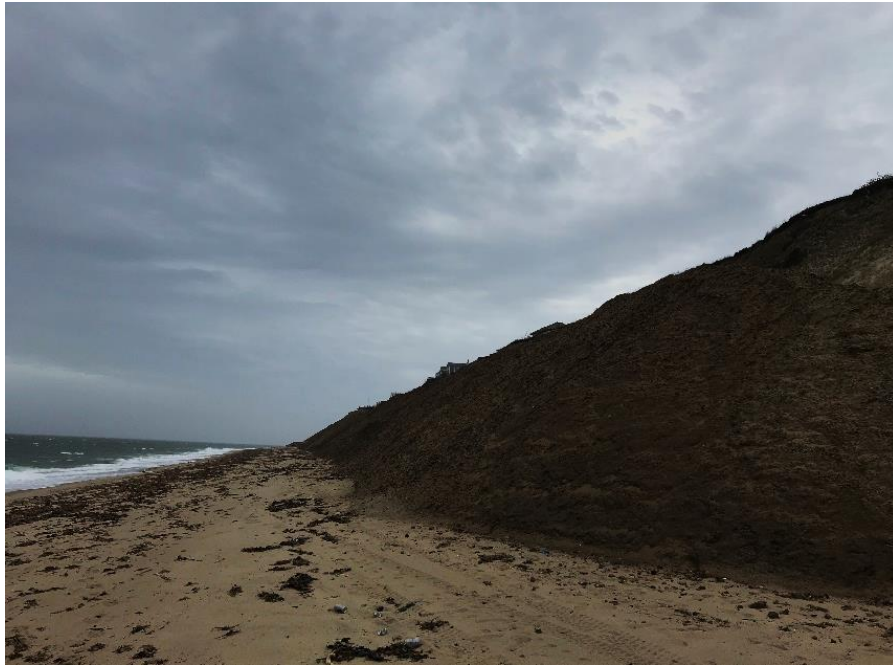
Site was in good condition.

GEO tubes completely covered

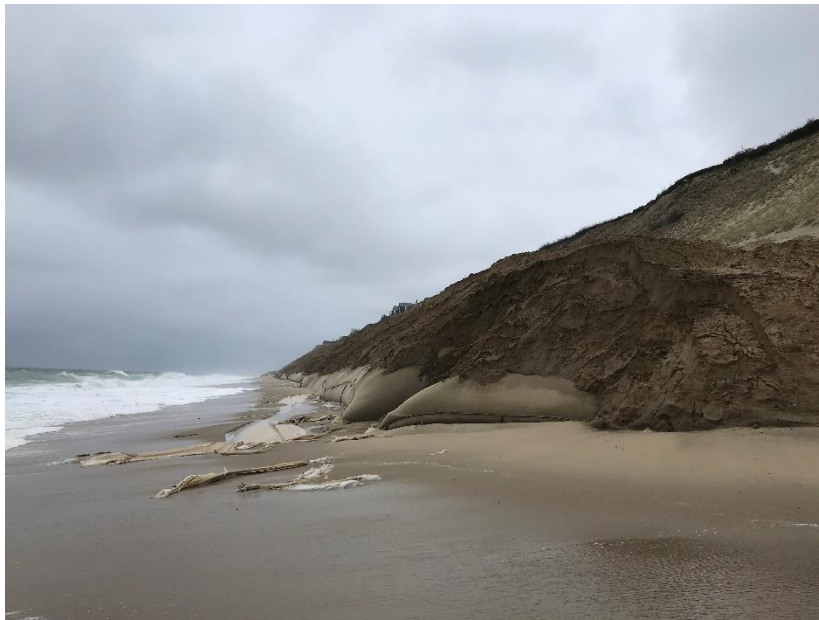
No access to beach due to active storm

Tube exposed significantly during last night's storm ~ 650'

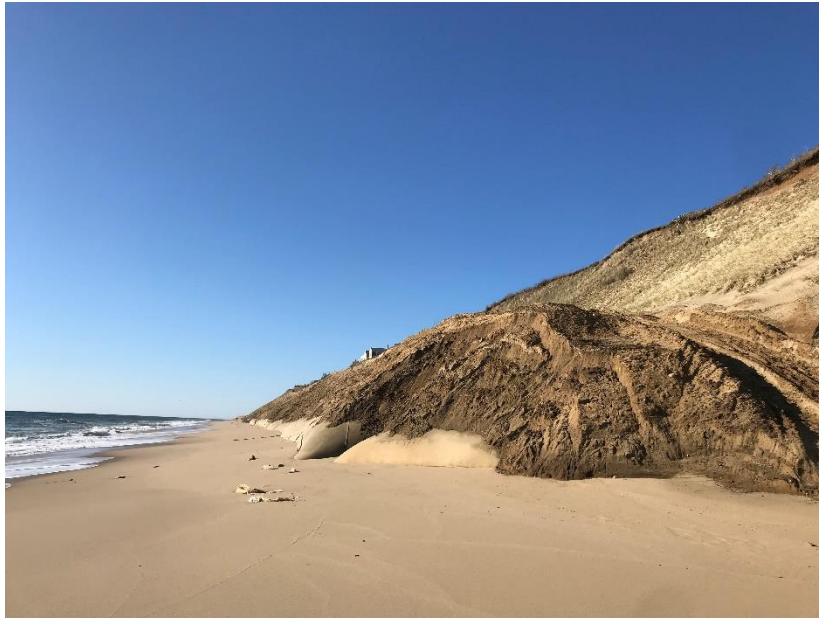
~600' of GEO Tube exposed

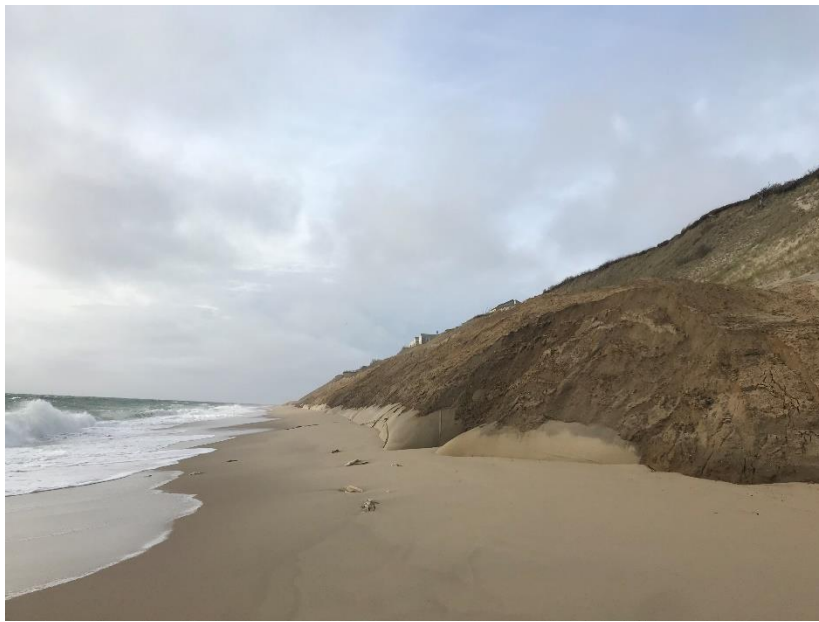
~570' of GEO Tube exposed

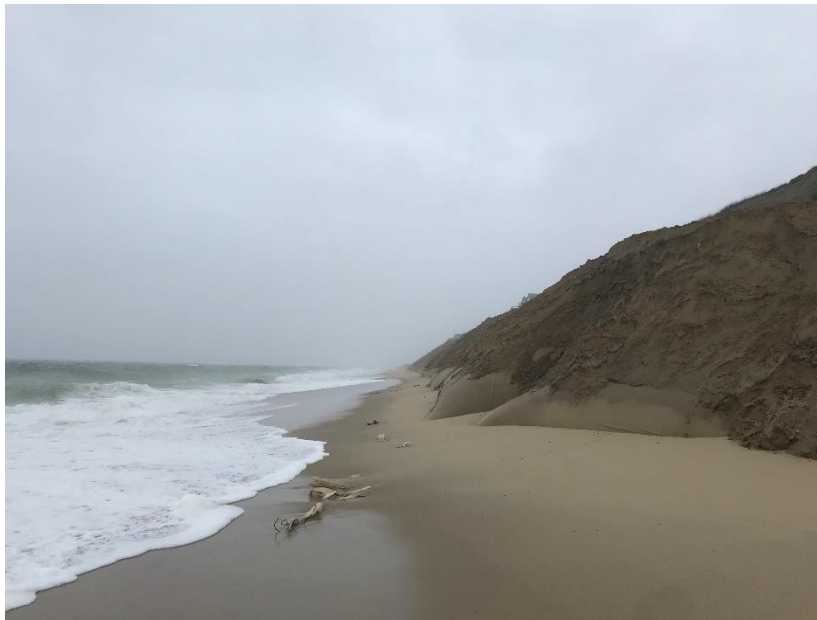
~500' of GEO Tube exposed
