Nantucket Town Pier – Post Storm (January 28, 2015, provided by Town)

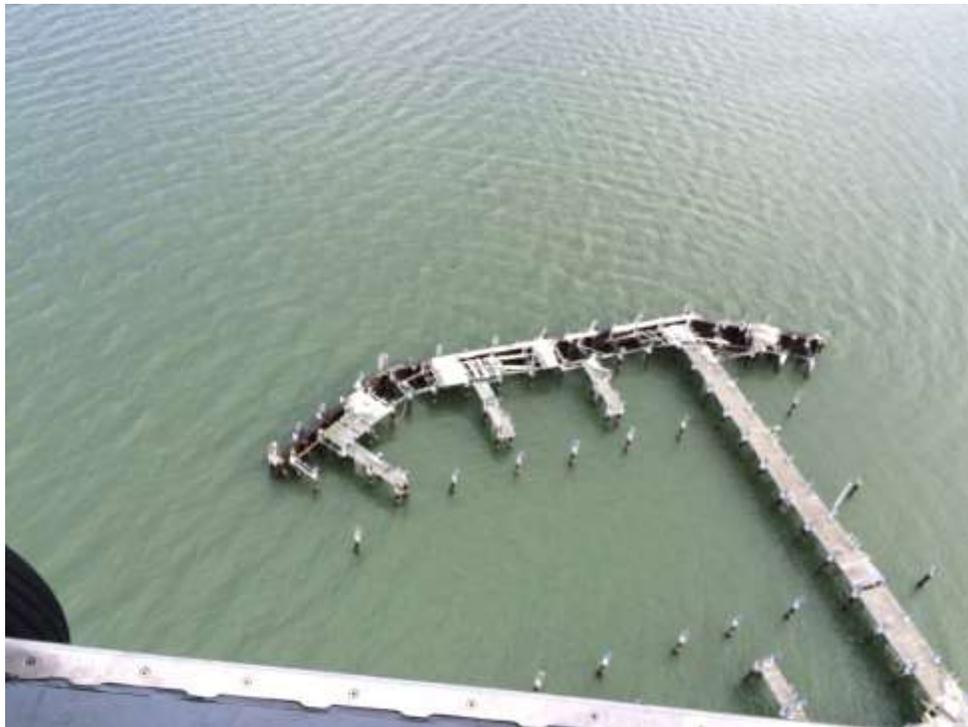
PHOTOGRAPH 2

Breakwater Pier Aerial (January 28, 2015, provided by Town)

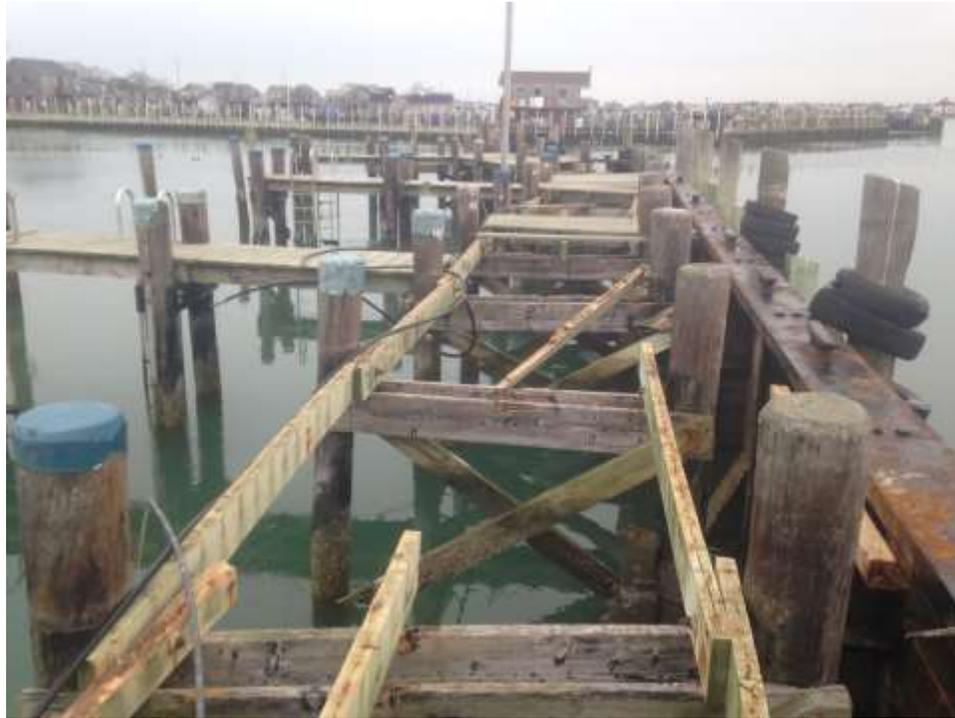
PHOTOGRAPH 3

Damage at Breakwater Pier structure, looking North.

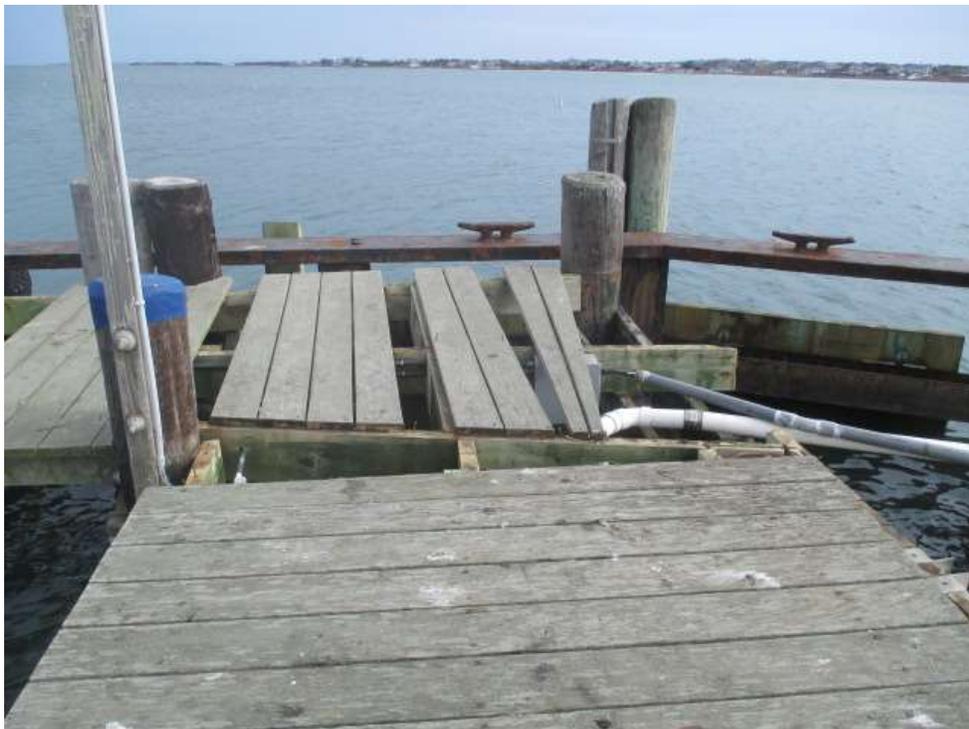
PHOTOGRAPH 4

Damage at Breakwater Pier structure, looking Northeast.

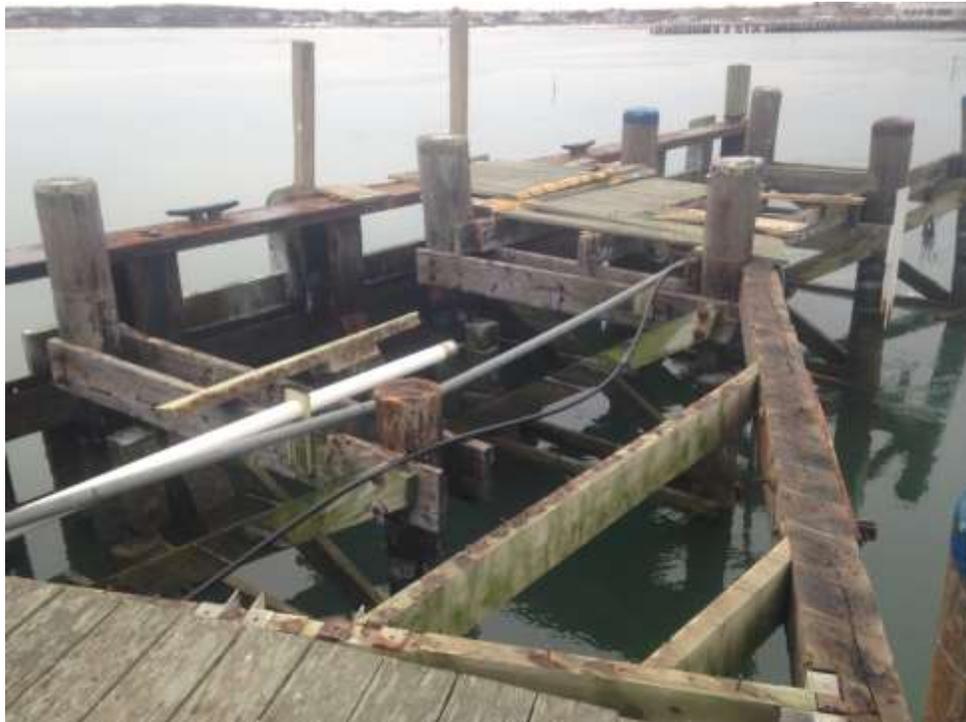
PHOTOGRAPH 5
Damage at Breakwater Pier Structure, looking South.

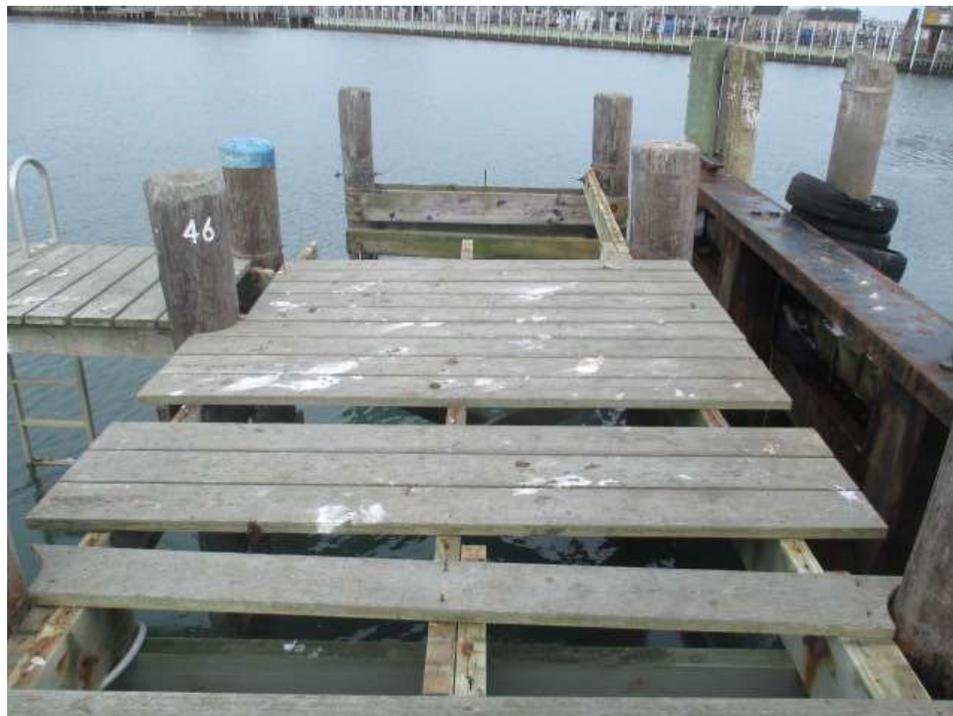
PHOTOGRAPH 6
Damage at North end of Breakwater Structure.
Note landward lean of piles, framing and decking.

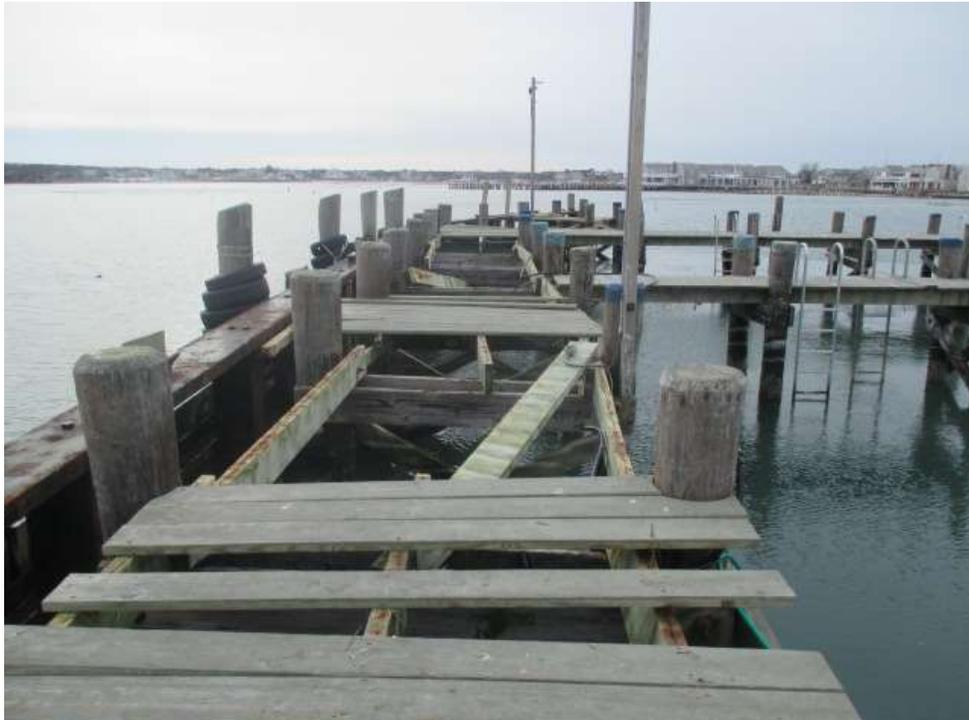
PHOTOGRAPH 7
Damage at North end of Breakwater Structure.
Note landward lean of piles, framing and decking.

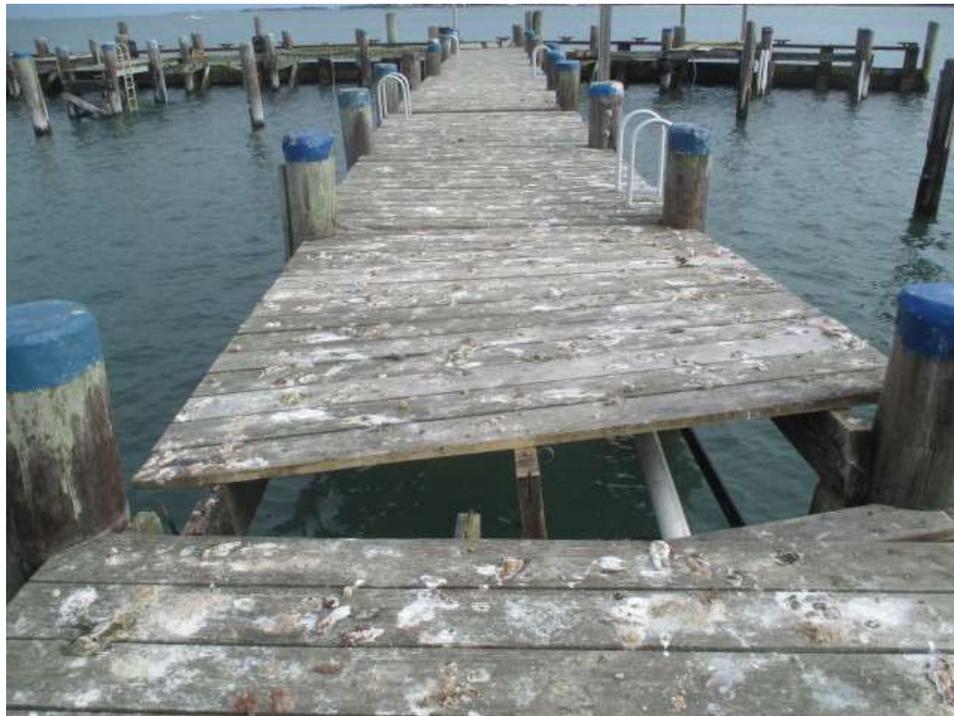
PHOTOGRAPH 8
Damage of Main Pier structure, between Bents 73 and 74.

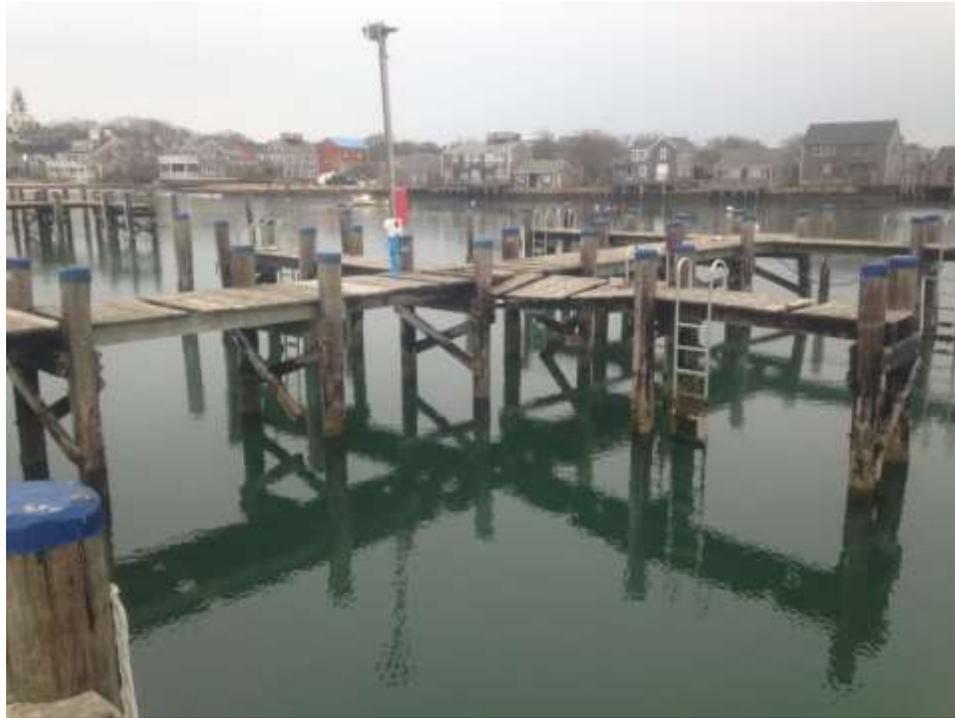
PHOTOGRAPH 9
Damage at Finger Pier 3.

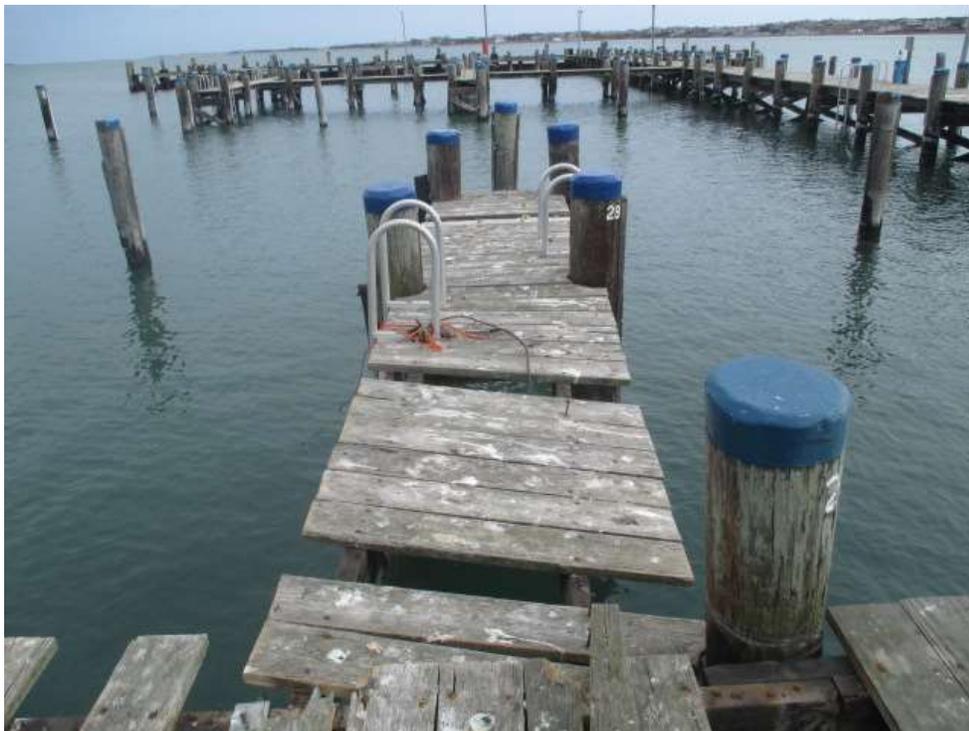
PHOTOGRAPH 10
Damage at Finger Pier 3.

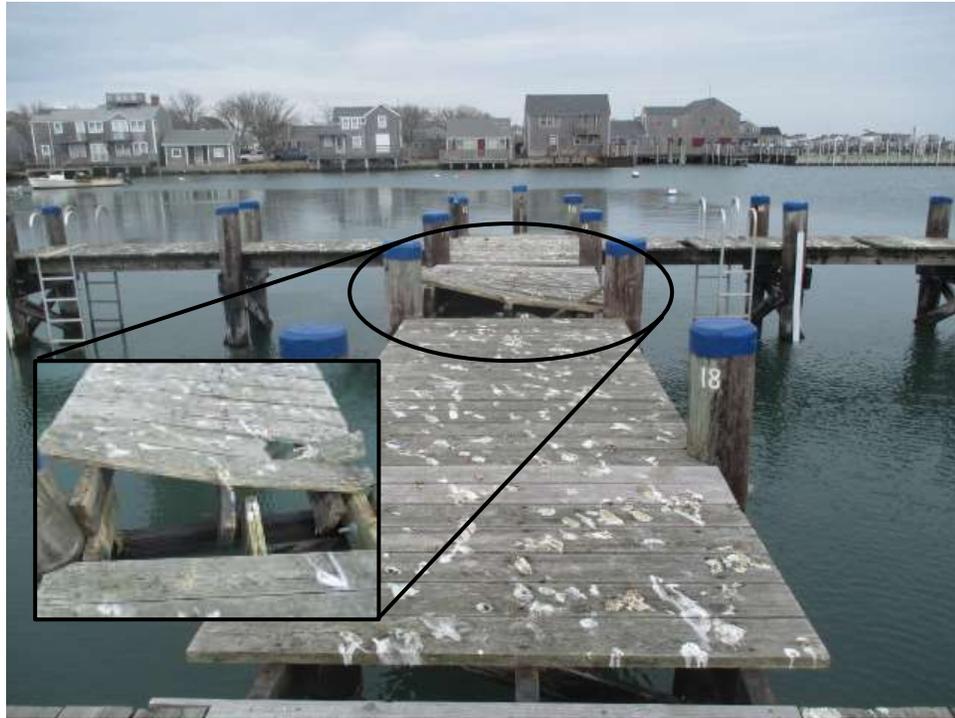
PHOTOGRAPH 11
Damage at Finger Pier 2.

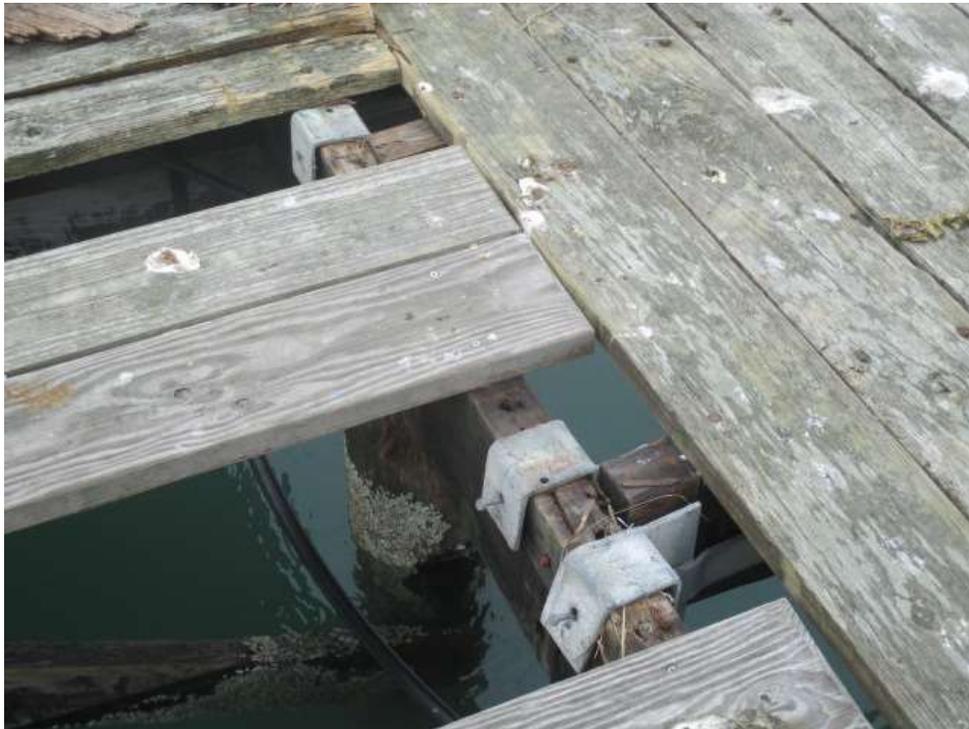
PHOTOGRAPH 12
Damage at Finger Pier connection to Main Pier. Note connection of stringers to be improved.

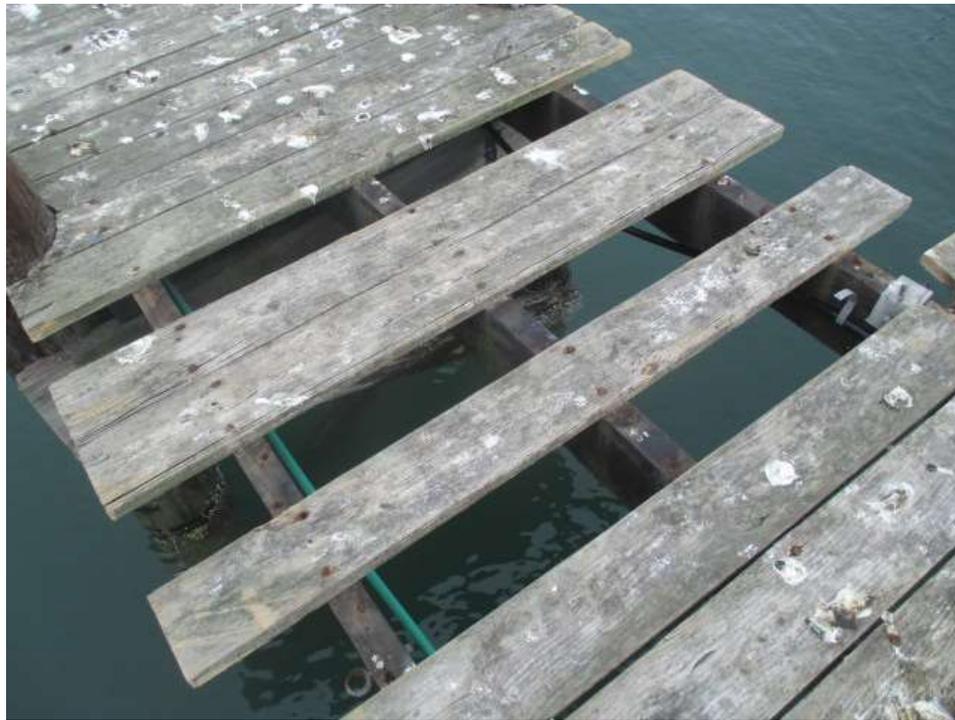
PHOTOGRAPH 13

Typical loss of deck boards along Main Pier and Finger Piers.

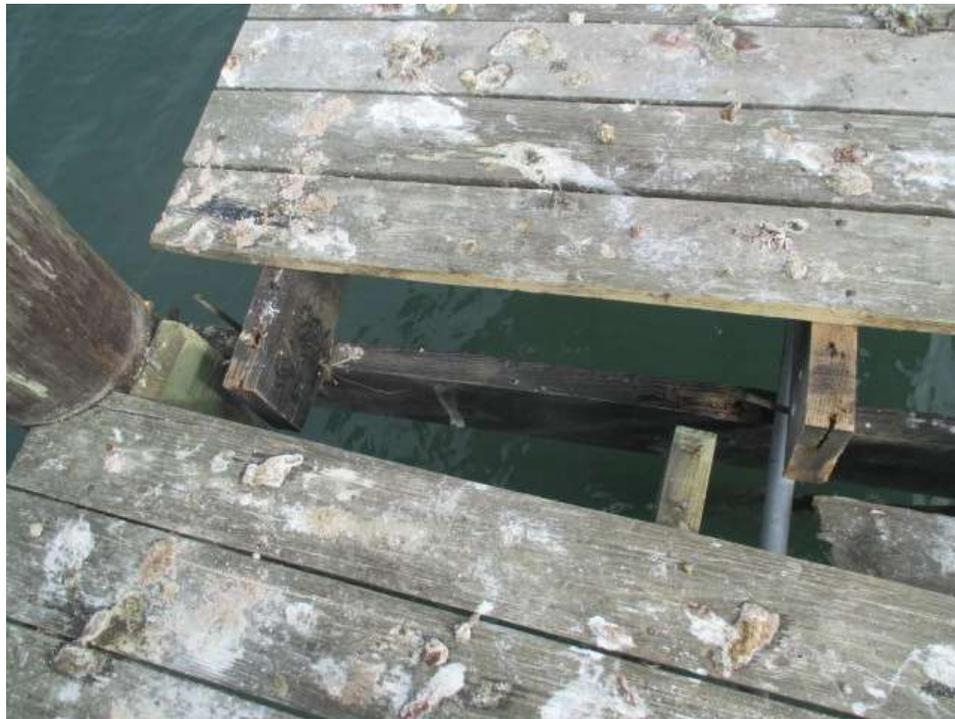
PHOTOGRAPH 14

Damaged drift pin connection from stringers to pile caps.

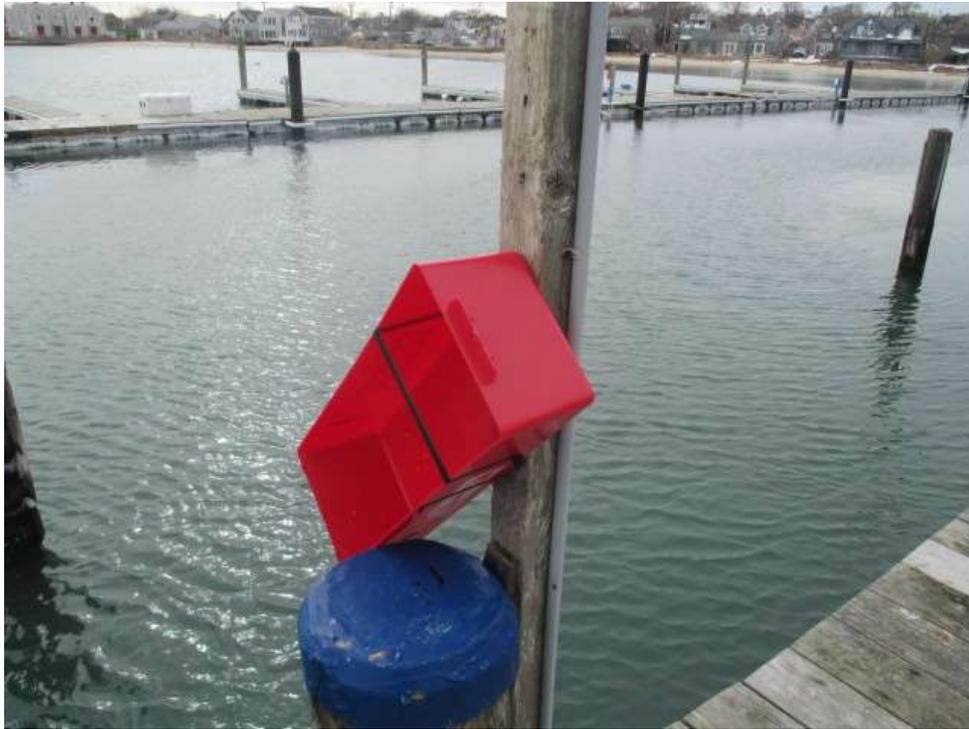
PHOTOGRAPH 15
Damaged fire extinguisher box.

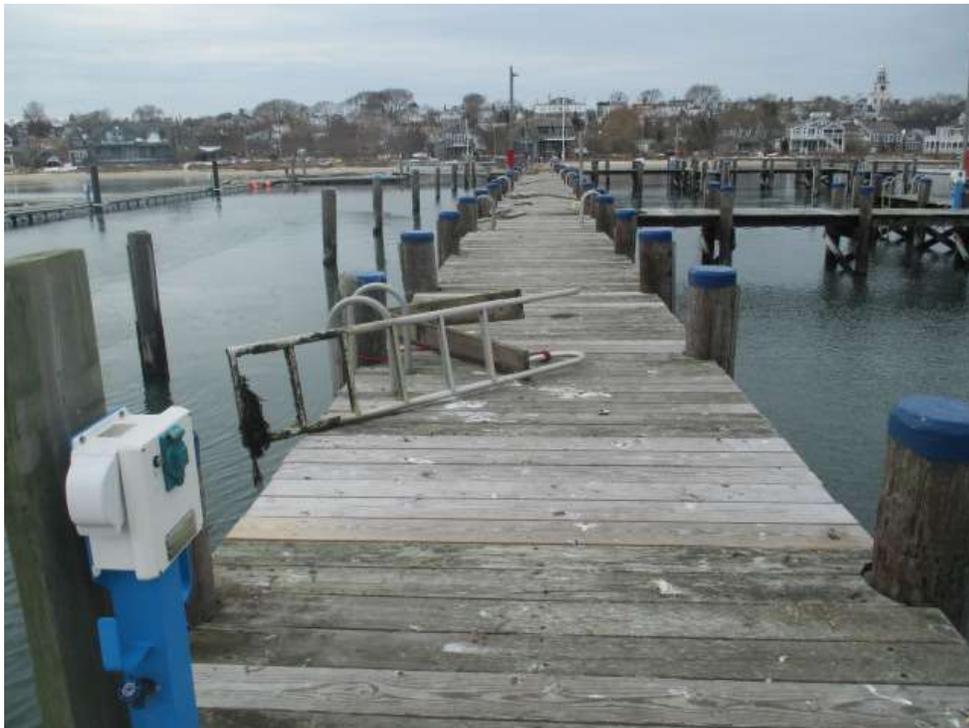
PHOTOGRAPH 16
Displaced aluminum ladder.

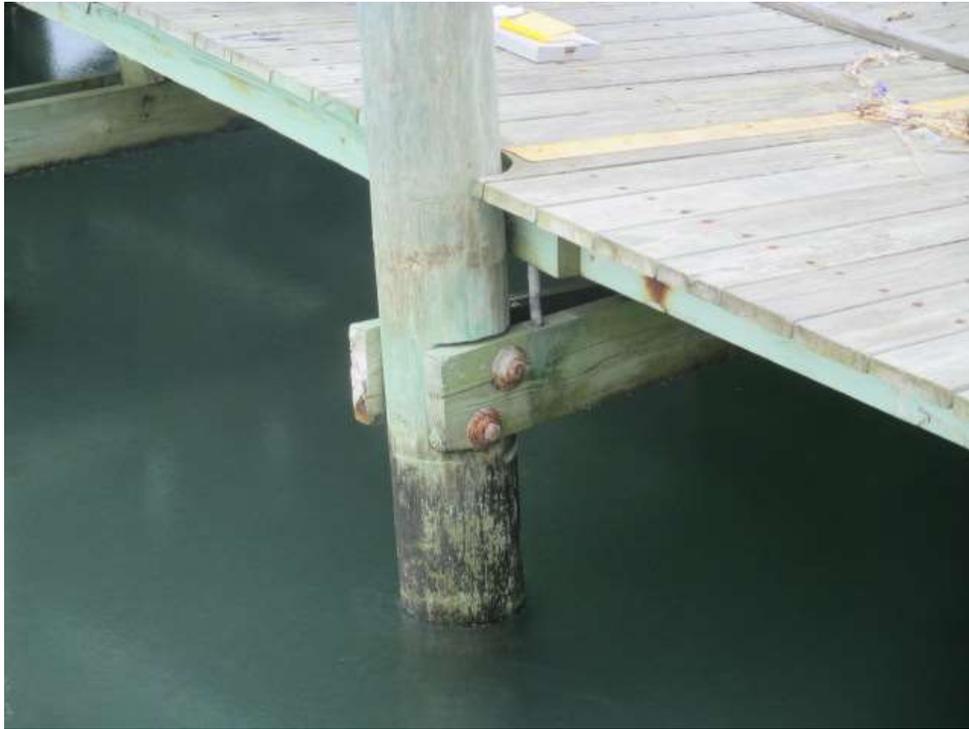
PHOTOGRAPH 17

Gangway Timber Platform uplift damage. Note platform stringer suspended on drift pin.

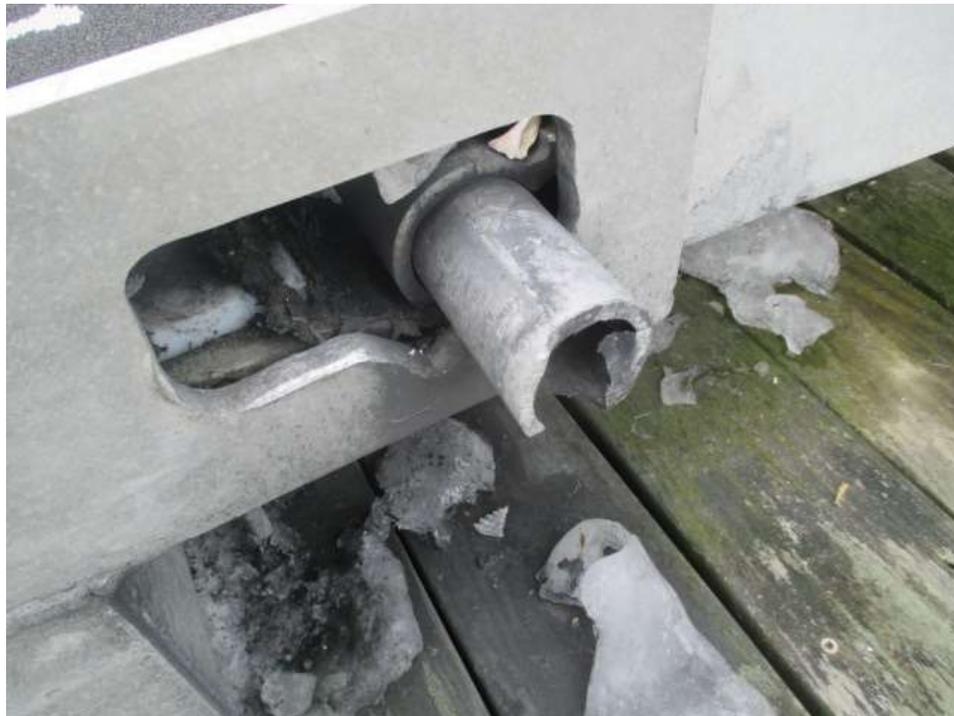
PHOTOGRAPH 18

Damage at float and aluminum gangway connection.

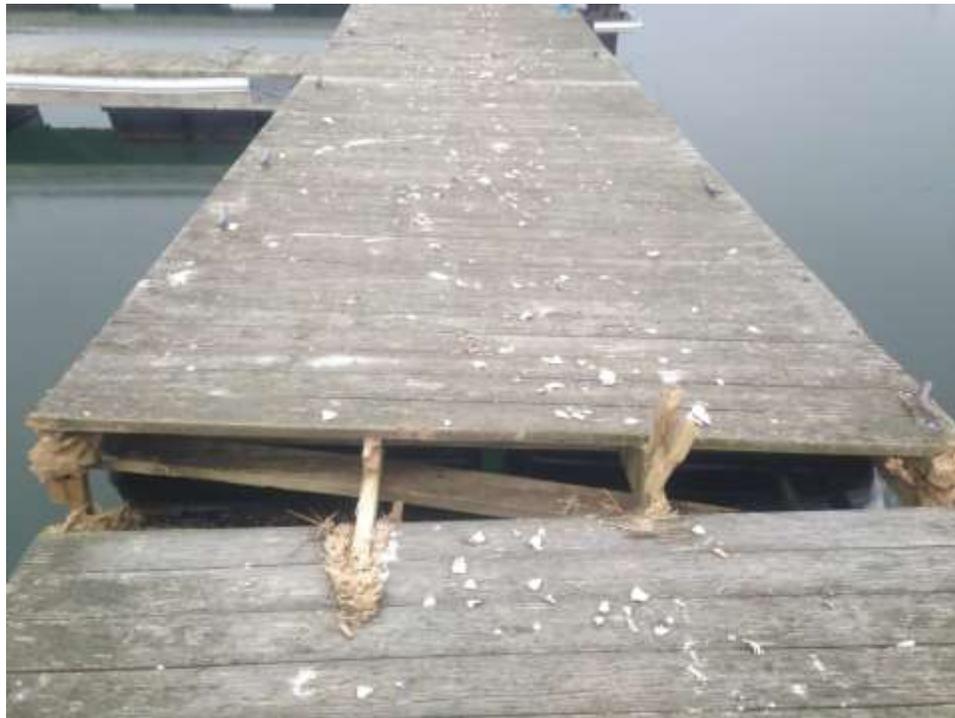
PHOTOGRAPH 19
Damaged timber floating dock section.

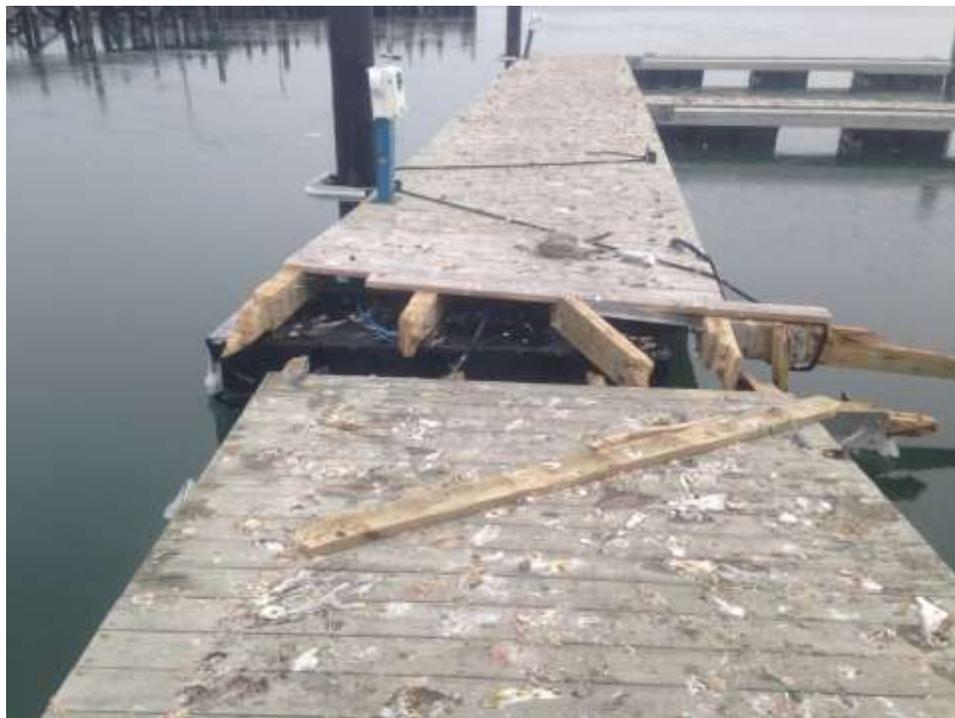
PHOTOGRAPH 20
Damaged timber floating dock section.

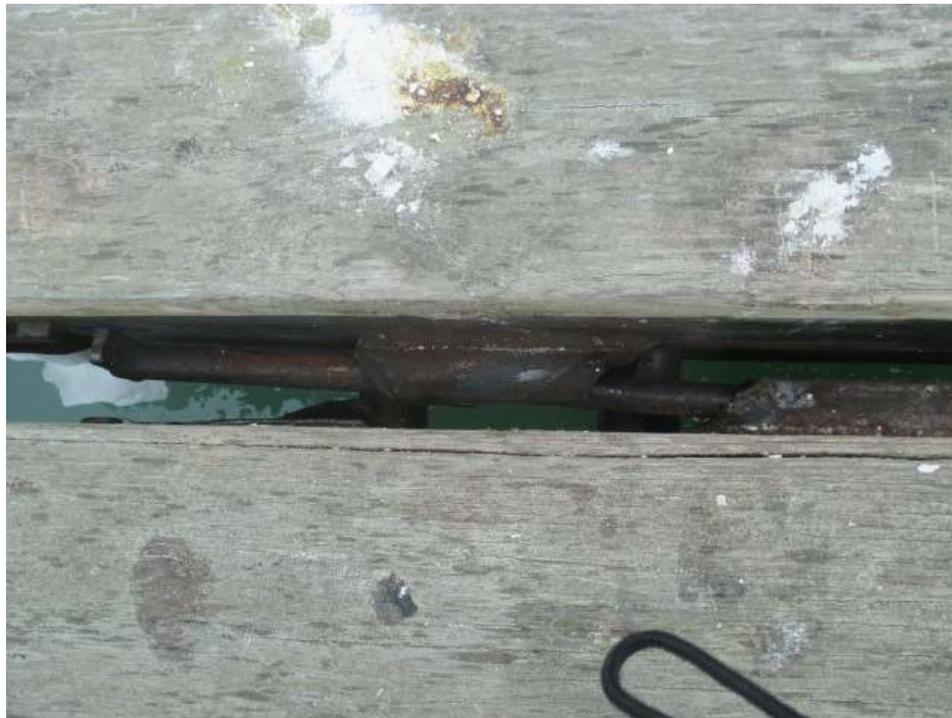
PHOTOGRAPH 21

Damaged float-to-float connection hinge.

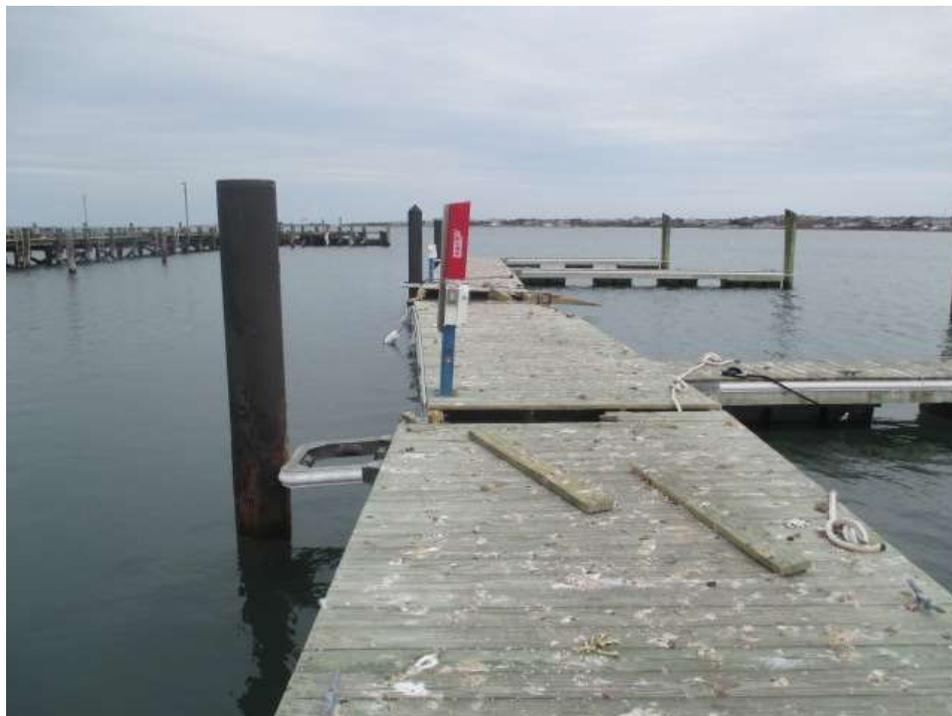
PHOTOGRAPH 22

Damaged timber float. Note pile guide not connected to steel pile.
Note missing finger float in background.

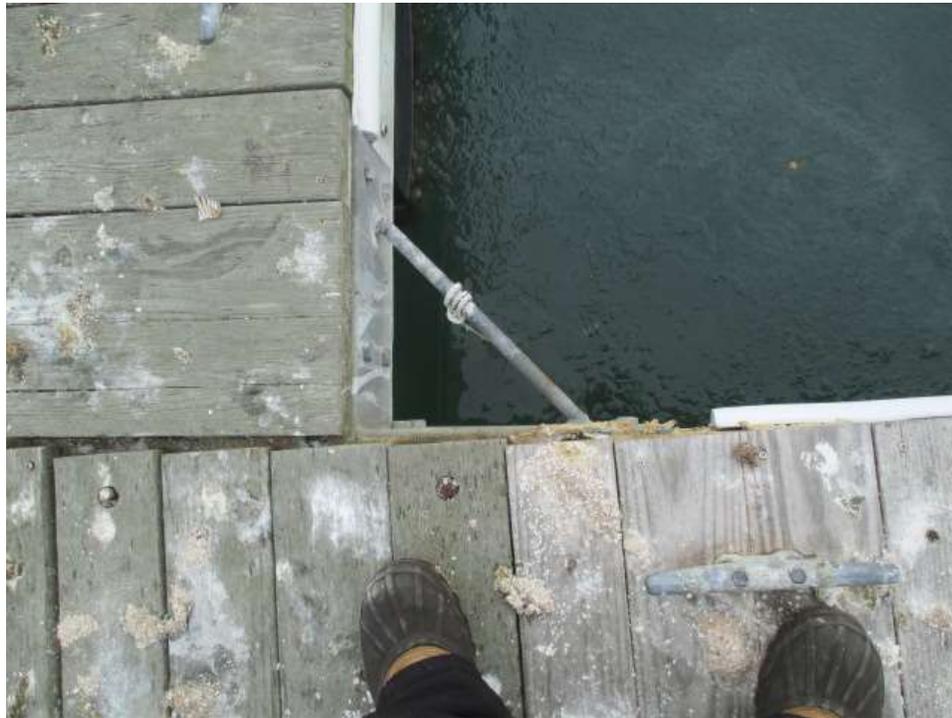
PHOTOGRAPH 23

Damage to previously repaired section of 8-foot wide floating dock.

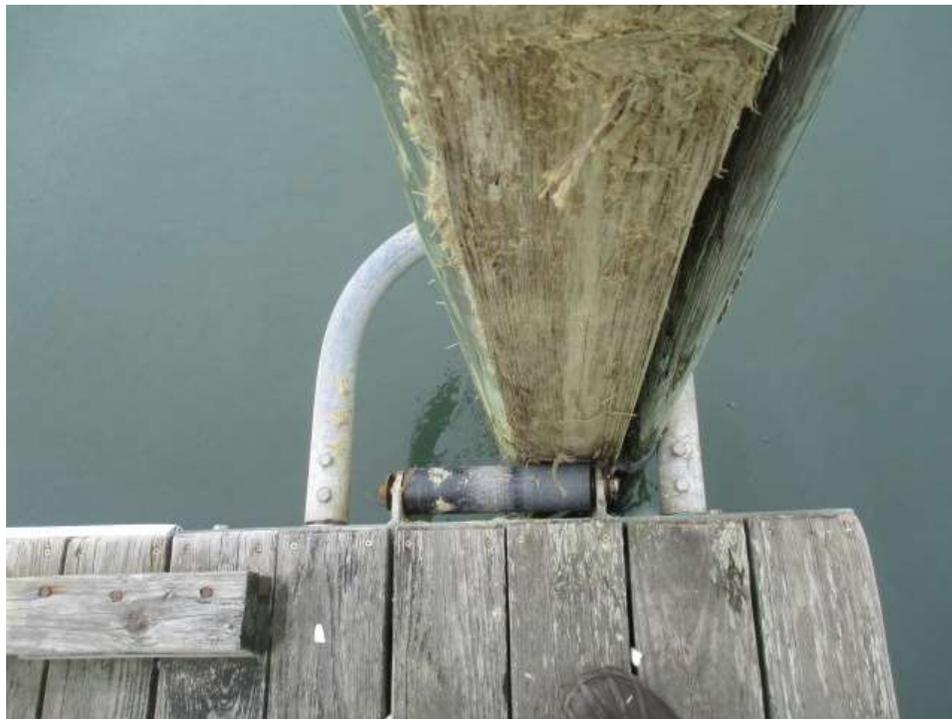
PHOTOGRAPH 24

Abrasion damage to existing timber pile. Note pile guide no longer aligned with pile.

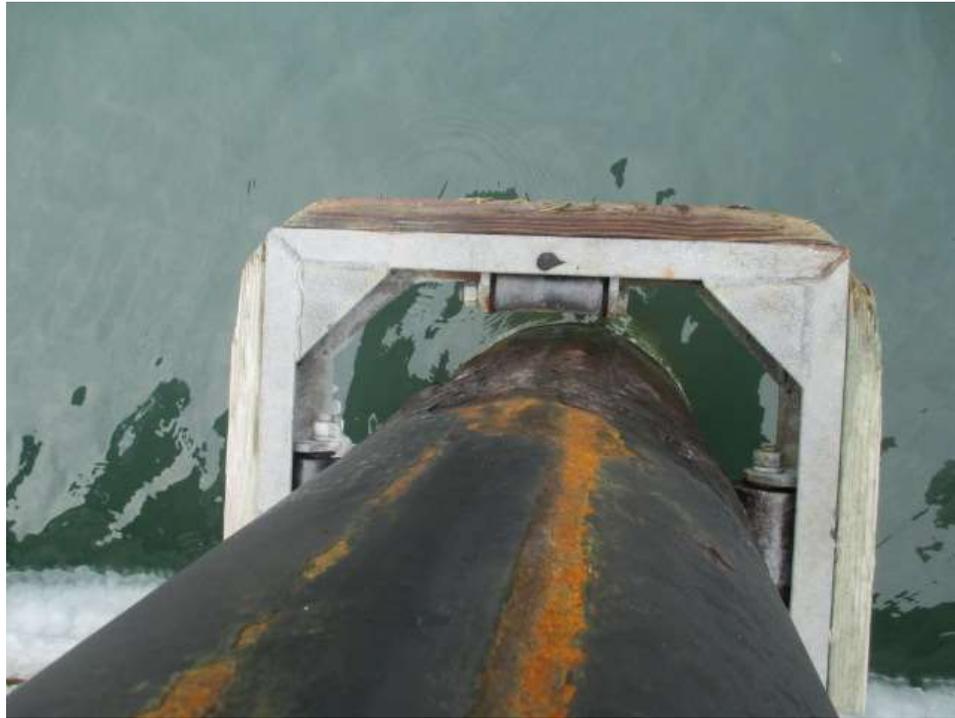
PHOTOGRAPH 25

Wearing of pile guide rollers at steel piles.

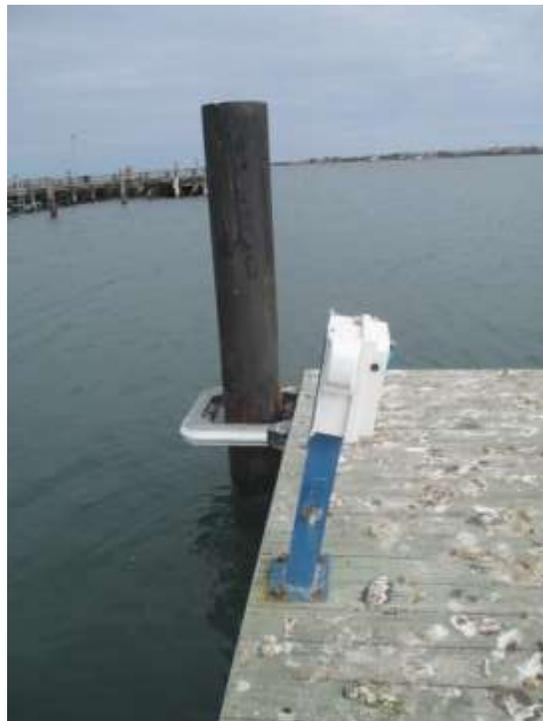
PHOTOGRAPH 26

Damage to existing power pedestal on timber floats. Note pile cap no longer attached to steel pile.
