NEW FIRE STATION WORK GROUP'S SUMMARY OF RECOMMENDATIONS AND FINDINGS

November 14, 2014

WHY THE PLEASANT STREET STATION IS OBSOLETE

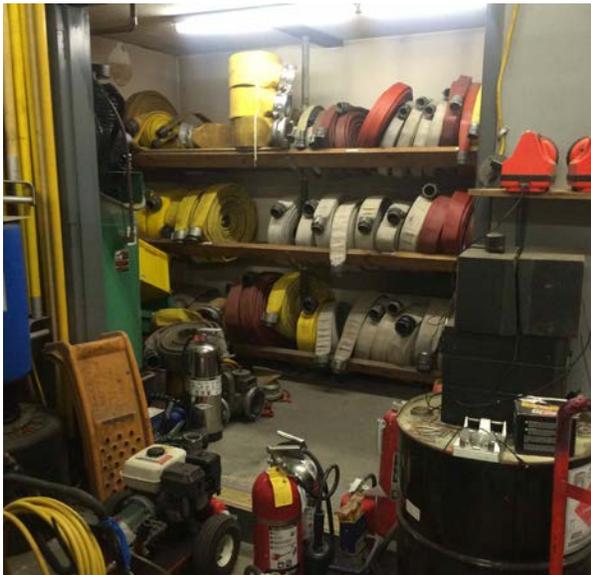
Improper Hose Storage:

- There are no adequate storage rooms for turnout gear, supplies, hose, equipment or contaminated items. Currently, equipment is stored under the rafters of the attic, in the hose tower, the mechanical room and on the floor of the apparatus bay.

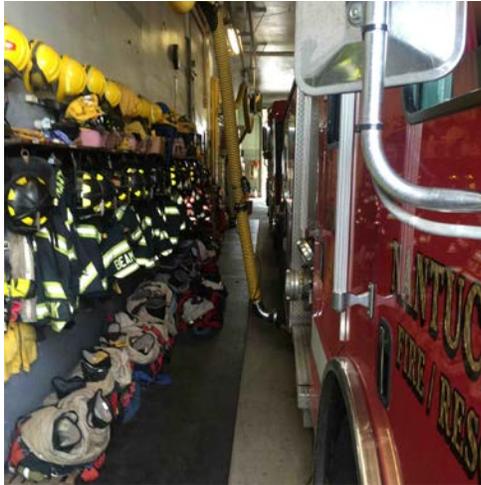
Inadequate Storage for Turnout Gear
