Jetty Repair  
Federal Navigation Project  
Nantucket, MA

*Board of Selectmen Meeting*  
November 5, 2014

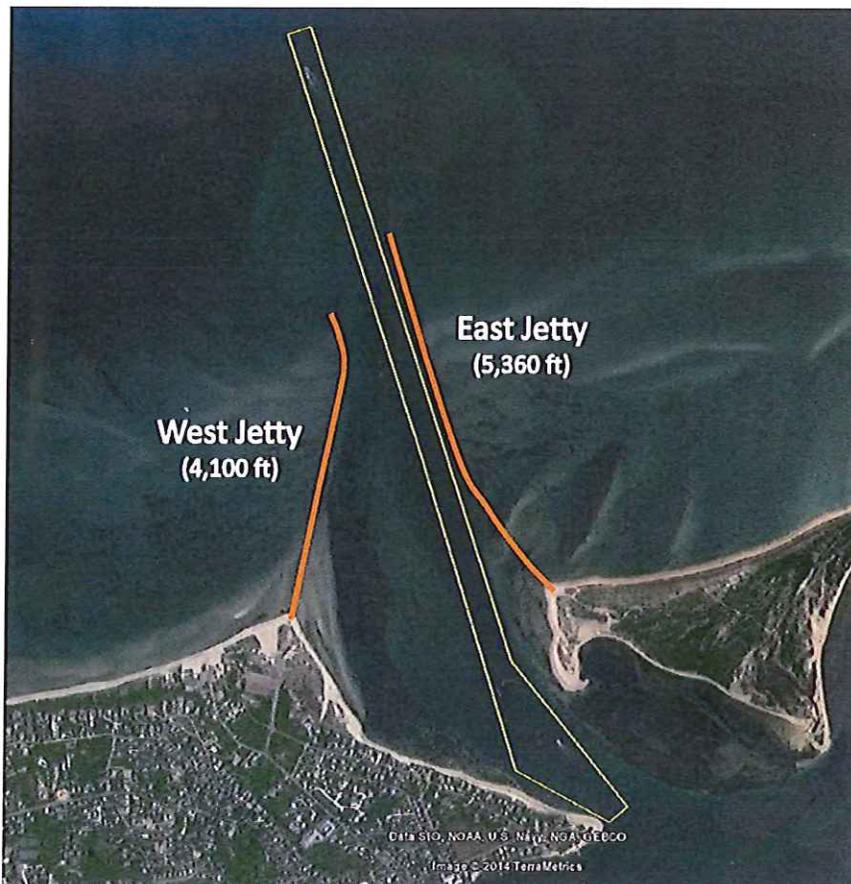
- Federal Project Consists of:
  - 15-ft Main Channel
  - 15-ft Turning Basin
  - East and West Jetties
- Focus of this Presentation
  - East and West Jetty Repairs
- Last Maintenance Event
  - East Jetty: 1963 (15,059 tons)
  - West Jetty: 1900 (4,750 tons)
- Basis for Repairs
  - Significant damage by Hurricane Sandy
  - Vessel strikes to jetties represent a human and health of the environment hazard

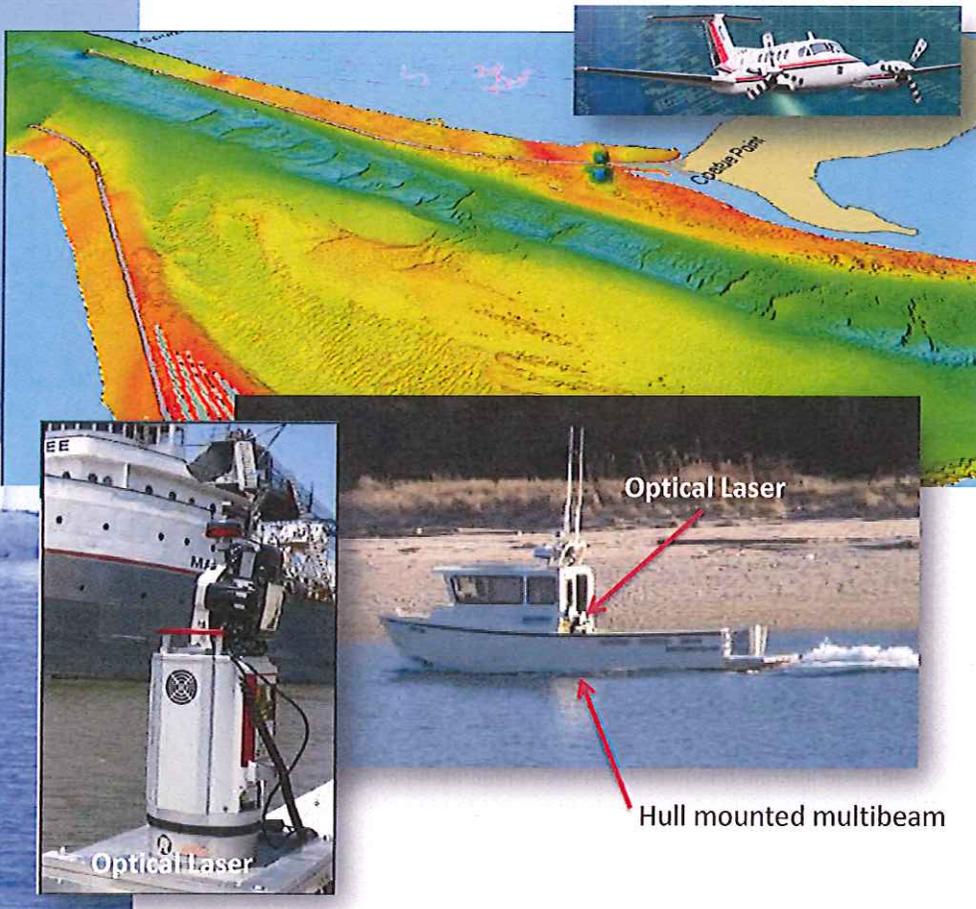
- LiDAR performed by USACE Joint Airborne LiDAR Bathymetry Technical Center of Expertise (JALBTCX) in May 2013
- Bathymetric/Optical Laser survey performed by Substructure Inc. under contract to the New England District.
- Substructure simultaneously collected multibeam sonar and optical laser survey over a two week period in July 2013.
- Data post processed to merge data sets for one seamless topographic layer.
- Combination provided complete high resolution coverage of federal navigation project.

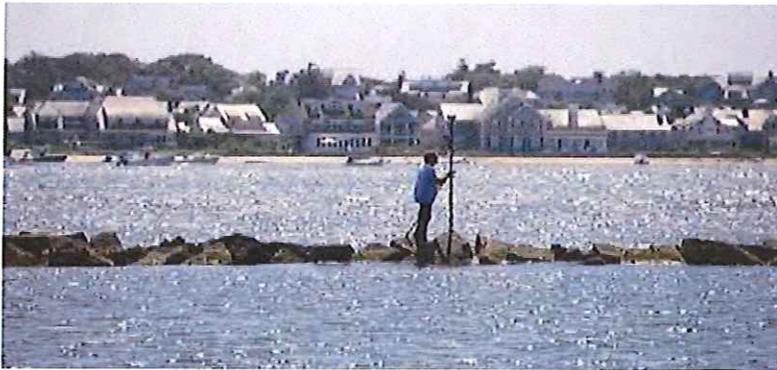
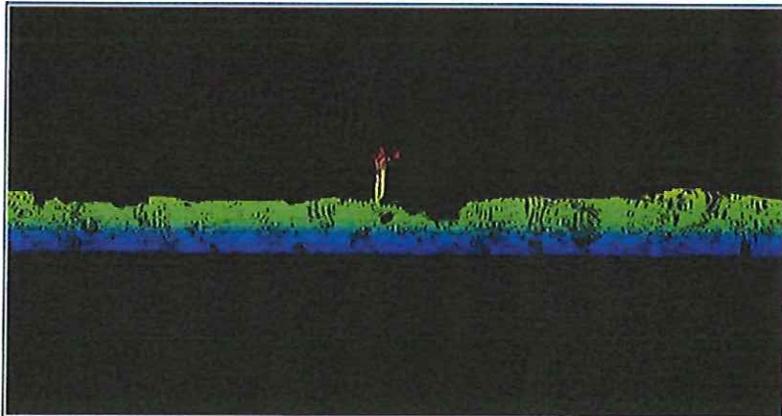
- LiDAR performed by USACE Joint Airborne LiDAR Bathymetry Technical Center of Expertise (JALBTCX) in May 2013
- Bathymetric/Optical Laser survey performed by Substructure Inc. under contract to the New England District.
- Substructure simultaneously collected multibeam sonar and optical laser survey over a two week period in July 2013.
- Data post processed to merge data sets for one seamless topographic layer.
- Combination provided complete high resolution coverage of federal navigation project.

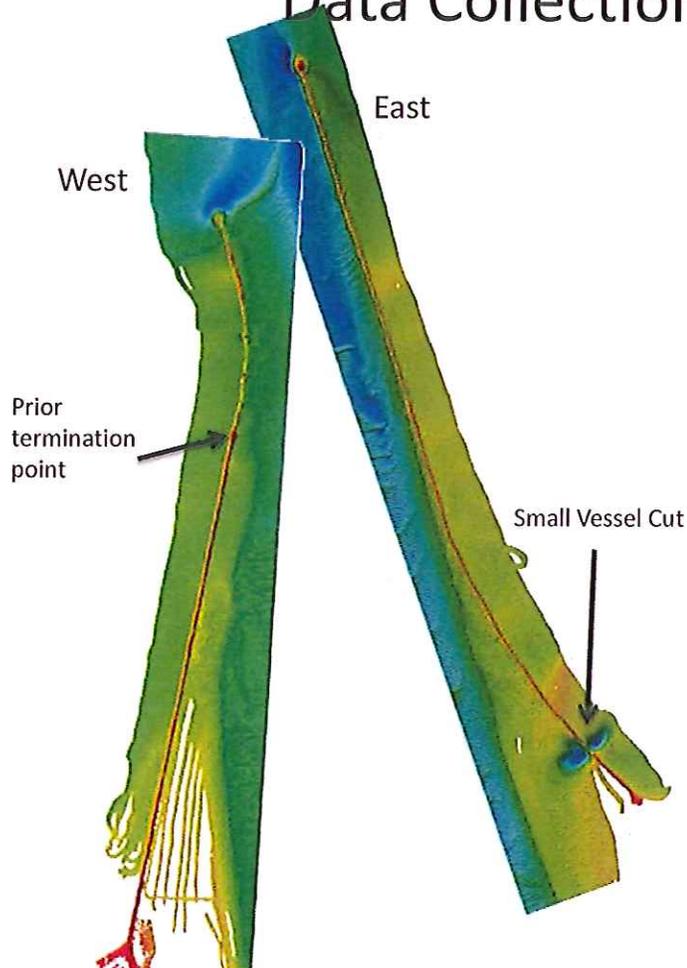
- LiDAR performed by USACE Joint Airborne LiDAR Bathymetry Technical Center of Expertise (JALBTCX) in May 2013
- Bathymetric/Optical Laser survey performed by Substructure Inc. under contract to the New England District.
- Substructure simultaneously collected multibeam sonar and optical laser survey over a two week period in July 2013.
- Data post processed to merge data sets for one seamless topographic layer.
- Combination provided complete high resolution coverage of federal navigation project.

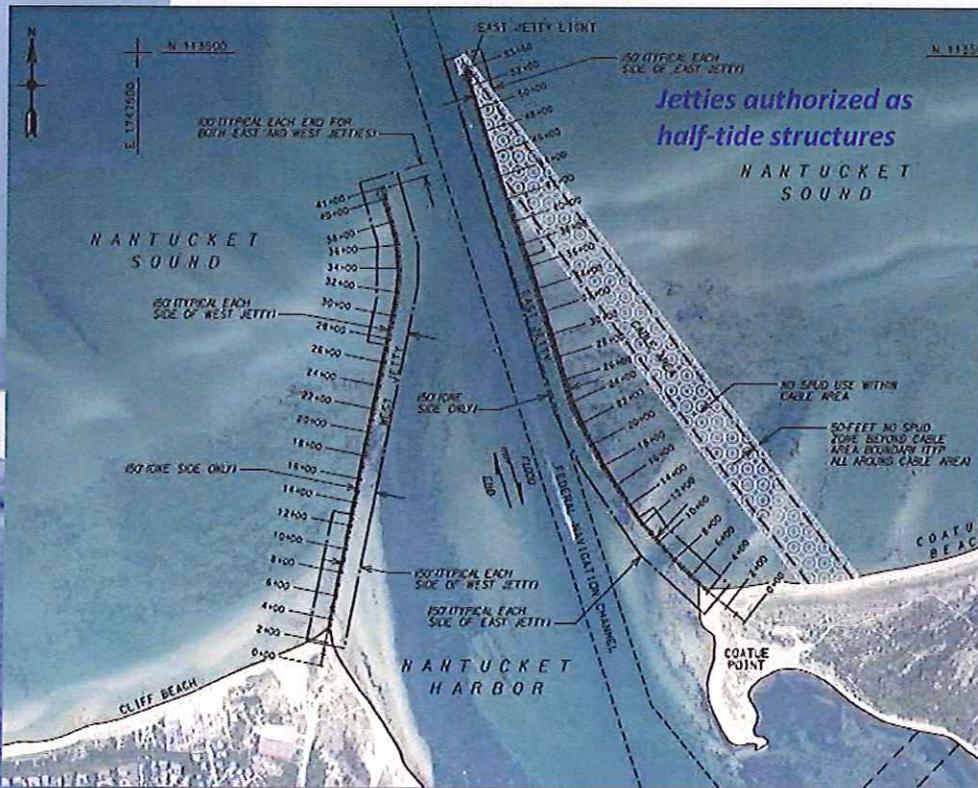
- Repairs will require approximately 32,300 tons of 2-4 ton stone to bring structures back to authorized dimensions.
- Crown widths / heights make working from crest of structure impossible. Work will be done from marine plant only with stone and equipment coming by barge.
- Jetties will be pulled apart to below water line where damage is less extensive and rebuilt to meet construction tolerances.
- Jetty Repair incorporates Sea Level Rise over the next 50 yrs.
- Authorized Design Heights
  - East Jetty : + 3.2 MLLW
  - West Jetty: + 5.2 MLLW
- Construction to begin in April 2015.

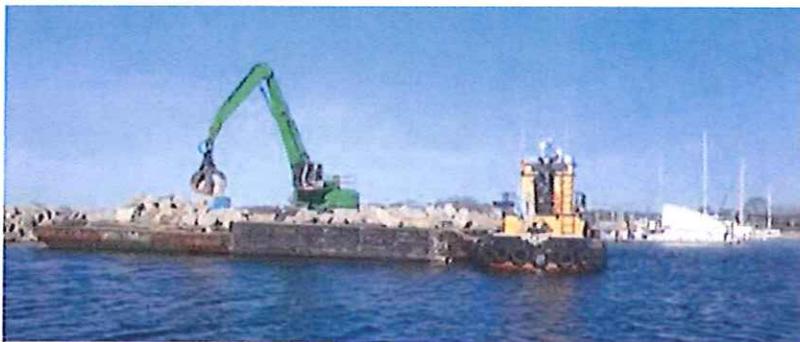
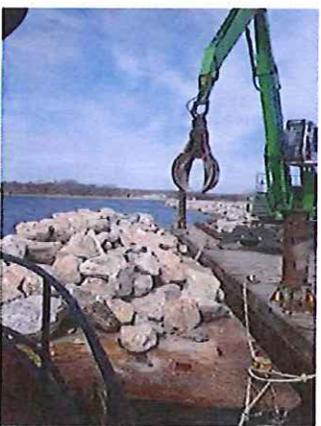
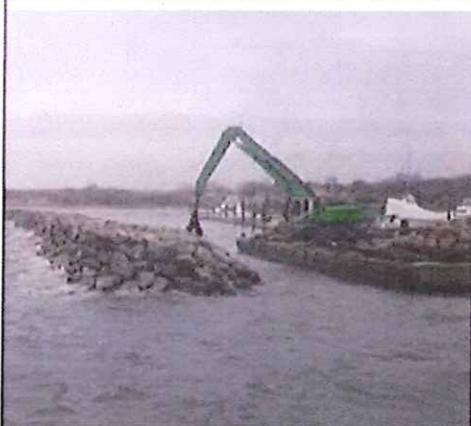
Photos Courtesy of Mohawk Northeast, Inc.

- Repairs will require approximately 32,300 tons of 2-4 ton stone to bring structures back to authorized dimensions.
- Crown widths / heights make working from crest of structure impossible. Work will be done from marine plant only with stone and equipment coming by barge.
- Jetties will be pulled apart to below water line where damage is less extensive and rebuilt to meet construction tolerances.
- Jetty Repair incorporates Sea Level Rise over the next 50 yrs.
- Authorized Design Heights
  - East Jetty : + 3.2 MLLW
  - West Jetty: + 5.2 MLLW
- Construction to begin in April 2015.

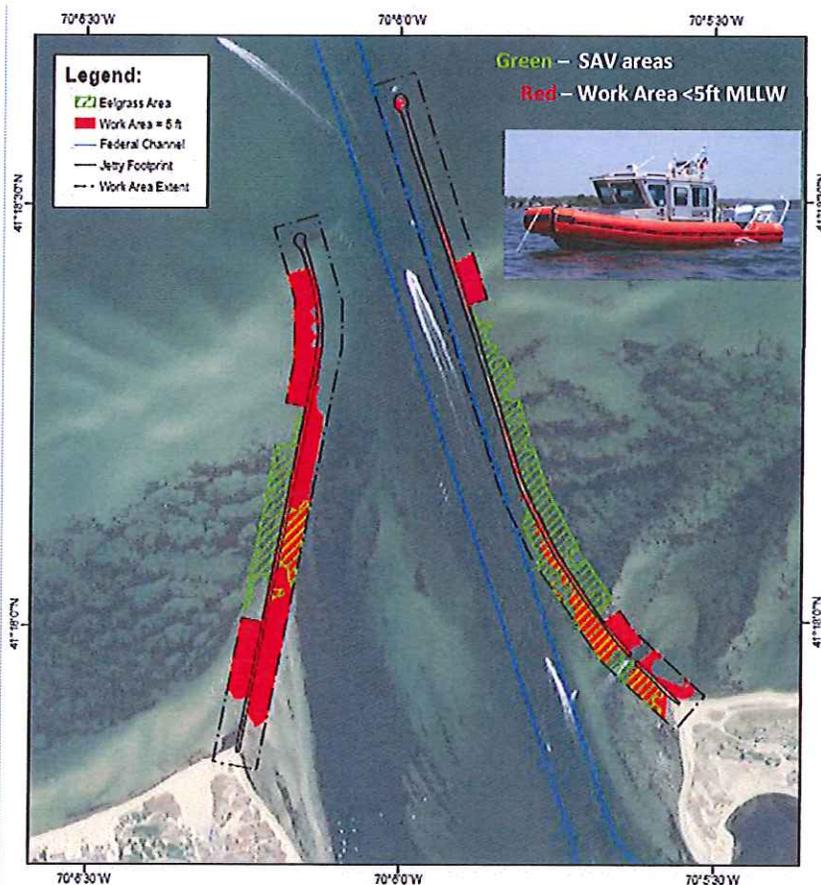
- Increased height of structure for visual identification by vessels to prevent strike (within authorized dimension requirements).
- Construction tolerances relaxed to +12 in. / - 6 in. to allow work from one side in areas of SAVs.
- Construction techniques reduces potential impact to SAVs from 18.5 acres to 6.9 acres.
- Due to limited depth in conjunction with barge drafts construction equipment may come into contact with ocean bottom. (Red areas)
- Construction techniques to reduce impacts to resources may increase total cost by up to 20 %.
