Miacomet Pond  
Annual Report  
2005

Prepared for:  
Marine and Coastal Resources Department  
34 Washington St.  
Nantucket, MA. 02554

Prepared by:  
Keith L. Conant  
Town Biologist

February 2006

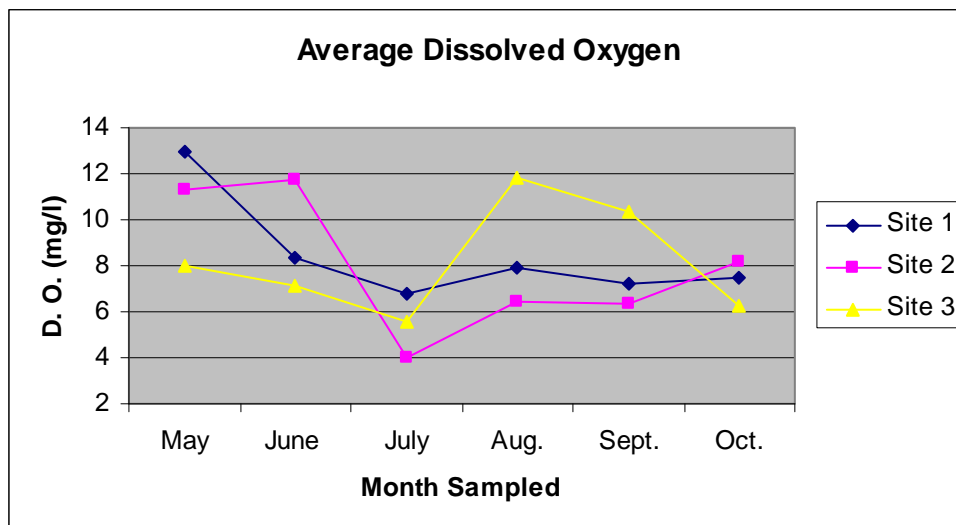
Figure 2: Average Dissolved Oxygen

Anoxic recordings were taken at bottom depths at Site 2 during July and August, and at site 3 during October (Appendix A). The average D. O. dropped noticeably at all stations during July (Figure 2), and was probably the result of ground water turning the pond back over to a predominantly fresh water system. This would cause the salt water phytoplankton species to die, which would then result in high levels of D.O. being consumed by bacteria. After this process was complete, and a fresh water system was re-established, average D. O. began to rise again at Sites 1, 2, and 3 (Figure 2). There was however a drop again in D.O. at Site 3, as eutrophic conditions dominated this area of low circulation. The biological oxygen demand was also probably high here, where intermittent draining had occurred, undoubtedly increasing the amount of decaying sub-aquatic vegetation.

Many marine and fresh water organisms can become stressed when D. O. levels fall below 4 mg/l. Anoxic conditions, which are more prevalent at night because of respiration, are being seen with more regularity when sampling during the day. These anoxic conditions are predominantly occurring on the bottom, and most fish can escape these episodic events. However, there is a benthic community that is vital to the ecology of the pond that will suffer high mortality when these conditions persist. Excessive pond weed, the result of high nutrient inputs, often results in higher than normal D. O. levels during the photic period. However, these D. O. levels drop to lower than normal levels at night because of respiration, and get even worse when layers of decaying organic matter result in the complete consumption of oxygen by bacteria. A release of gasses from this anoxic mud was witnessed one calm morning (9/7) at Site 1, when the anchor was deployed and a 50 ft. radius of bubbles erupted around the boat.

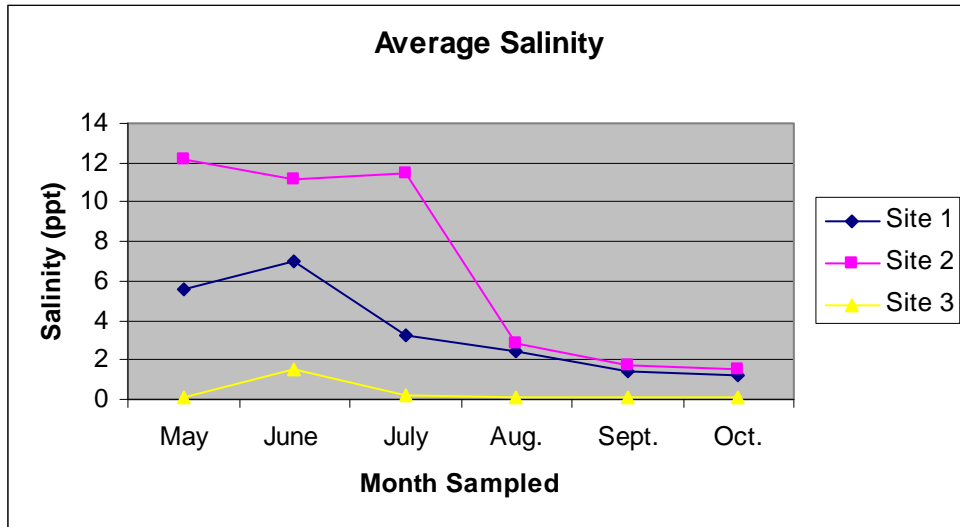
Figure 3: Average Salinity

These successive openings basically turned Miacomet into an estuary, with a well defined salt water wedge. Salinity peaked on the bottom near the foot (Site 2) of the pond in July, where it was measured at 23 ppt. At the same location at the same time, surface salinity was measured at 3.7 ppt. (Appendix A). Sites 1, and 3 heading away from the ocean were not nearly as high, but were better mixed, with no visible gradient at this time in July. By the time of the August sampling round the salinity had equalized and dropped off considerably throughout the pond, with the most saline area being only 3.5 ppt at the foot (Site 2) on the bottom. During the next two months the pond continued to turn fresh with lower salinity levels, that were well mixed at all stations. By October Sites 1, 2, and 3 measured 1.2 ppt., 1.5 ppt., and 0.1 ppt. respectively.

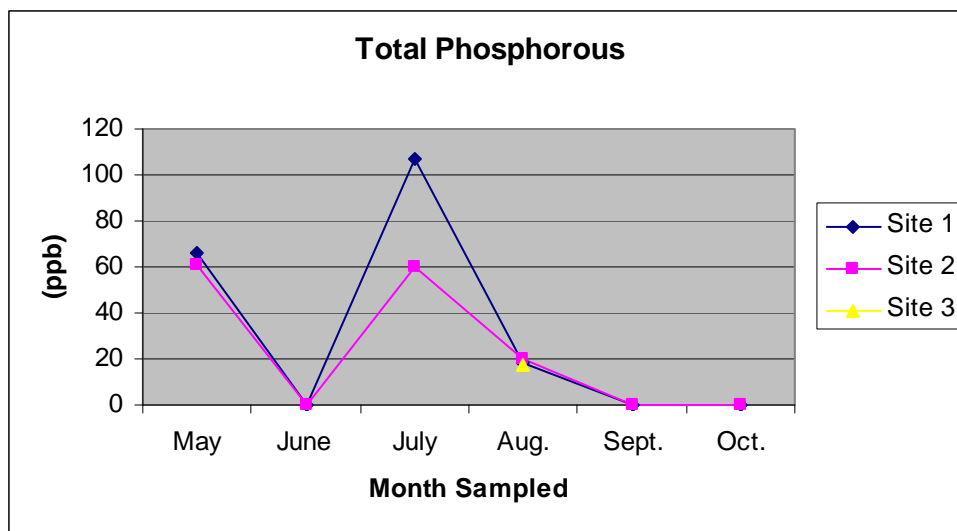
Figure 8: Total Phosphorous

Total phosphorous is predominantly the limiting nutrient for plant growth in a fresh water system. This is usually the case in Miacomet, however as previously discussed when this pond is transformed into a marine system, nitrogen becomes the limiting nutrient. Total phosphorous levels at or between 15-25 ppb, would be indicative of a mesotrophic system with good to fair water quality. Initially the readings at Sites 1, and 2 were both around 60 ppb (Figure 8), already high enough to indicate a hyper-eutrophic state. These values dropped below the reportable limit in June, but jumped even higher in July than initially detected. This shows a correlation between the flip flopping of the system from fresh to marine, and back again; and the abundance or absence favored nutrients.

By the third round of sampling in July when the system was predominantly marine, TP values peaked at Site 1 to 107 ppb. The TP value at Site 2 was also back to its starting point when sampling began. This was also the time when nitrogen values were at their lowest. Perhaps this is because TP was not being as rapidly used up in the now marine aquatic system as TN. This can be further explored as a possibility, for by the fourth round of sampling TP was rapidly declining, and TN was rising; as the system became once again fresh. TP continued to drop off below the reportable limit for the last two sampling rounds, as the fresh water influence from the watershed re-established its dominance.
