ROAD SAFETY AUDIT

Milestone Road

Nantucket, MA

Prepared For:
Massachusetts Department of Transportation

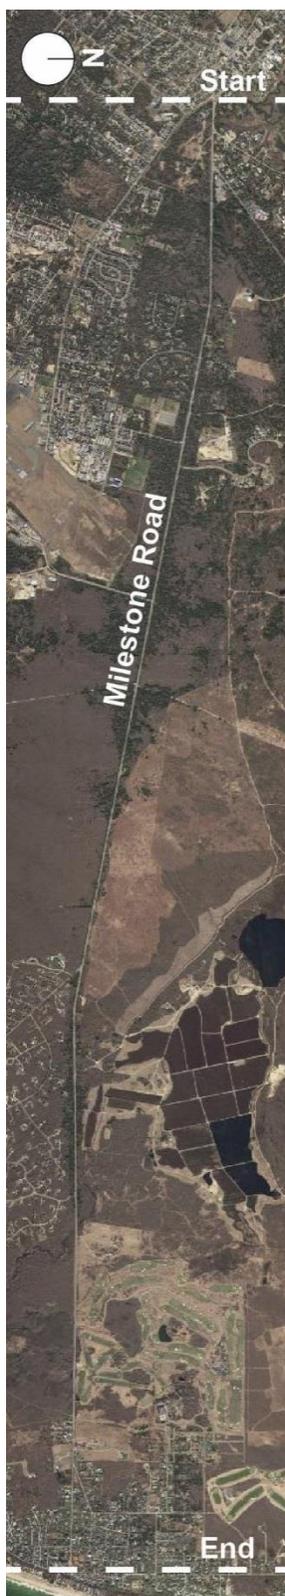
Figure 1: Milestone Road Corridor

The RSA was conducted for Milestone Road and Main Street in Nantucket, MA for the approximately six-miles of roadway extending between the Milestone Rotary to the west and the Sconset Rotary to the east. Milestone Road changes to Main Street at the intersection of New Street. The corridor is classified as a Rural Minor Arterial west of Nobadeer Farm Road and a Rural Major Collector east of Nobadeer Farm Road. The corridor is the primary east-west running thoroughfare providing vehicle, freight, bus, pedestrian, and bicycle transportation across the island. Milestone Road/Main Street is a two-way, two-lane roadway and connects the two main town centers on the island, the historic Downtown and Sconset. The two-way roadway is divided by either a double solid yellow line (indicating no passing allowed) or, along some sections of the road, a dashed yellow line (indicating that passing is allowed). The roadway is approximately 21 feet wide.

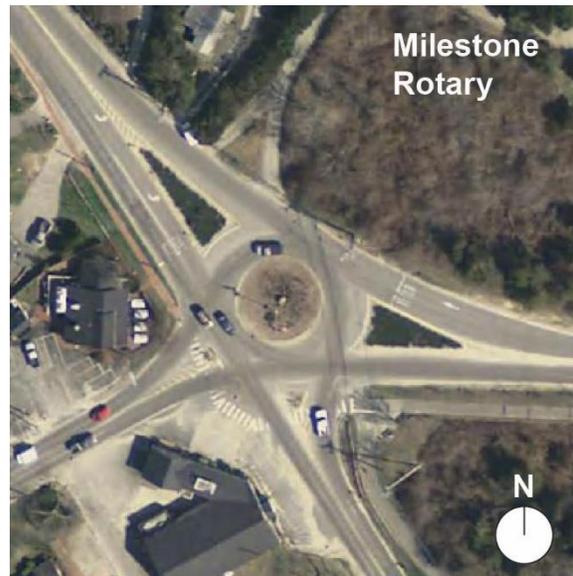
Figure 2: Milestone Rotary

- **Milestone Rotary:** The Milestone Rotary (see Figure 2) is the westernmost end of the RSA study area. The small rotary accepts traffic from four roadways including Old South Road to the south, Sparks Avenue from the west, Orange Street from the north, and Milestone Road from the east. The Milestone Rotary is unsignalized and each approach is outfit with a diverter island. All approaches are yield-controlled with the exception of Sparks Avenue which is stop-controlled. The off-road Sconset Bike Path begins at the Milestone Rotary where it meets the Old South Bike Path, which continues south. All roadways connecting to the rotary except for Milestone Road are owned and maintained by the Town of Nantucket. Crosswalks are provided along the southern and western legs of the rotary, however none are provided along the Milestone Road or Orange Street legs of the intersection.

The audit team noted that control features for the Milestone Rotary are inconsistent from approach to approach. The eastbound Sparks Avenue approach is stop-controlled, while the other three approaches are yield controlled. Rear end collisions were noted as a common crash type at this intersection, accounting for five of eight (62.5%) crashes reported at the Milestone Rotary. Failure to yield was also noted as the cause of a crash for one (12.5%) crash at this location, although advance warning signs are provided on the Milestone Road approach to the rotary.

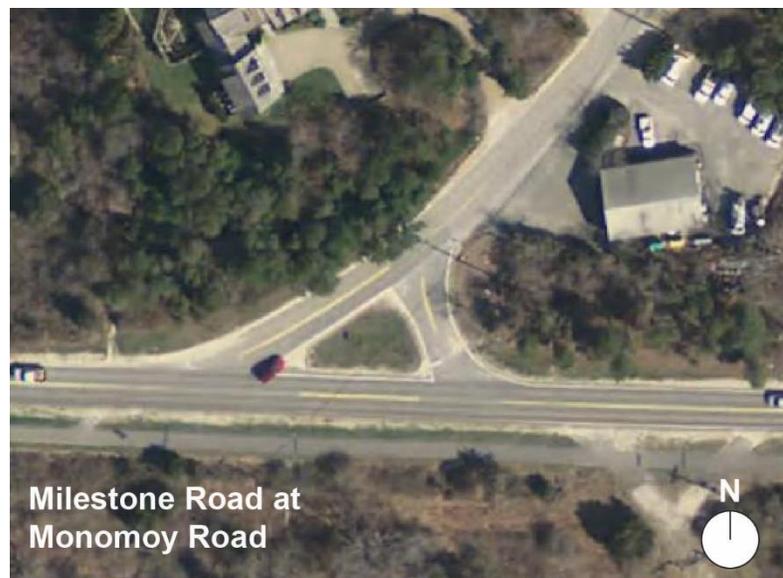
Figure 3: Milestone Road at Monomoy Road

- **Milestone Road at Monomoy Road:** The intersection of Milestone Road and Monomoy Road (see Figure 3) is a three-way unsignalized intersection with Monomoy Road meeting Milestone Road from the north. Monomoy Road is a two-way, two-lane roadway owned and maintained by the Town of Nantucket. A traffic island is located on the Monomoy Road approach and channelizes turning traffic. No crosswalks or ADA-compliant ramps are provided along any leg of the crosswalk. A westbound bus stop for the seasonally-run bus is located on the traffic island at the intersection, however no crosswalks to or from the traffic island are provided.

The audit team expressed concerns about the existing intersection design. The existing splitter island on the southbound Monomoy Road approach provides for two-way channelized turning movements on both sides of the splitter island. The audit team discussed that a T intersection alignment is preferred to reduce confusion, improve driver sight lines, and slow turning speeds. Members of the audit team also noted that while no crashes were reported at this intersection during the study period, rear end collisions occur at this intersection. Members of the audit team noted that a yield sign instead of a stop sign is provided at the southbound approach for vehicle wishing to turn onto Milestone Road westbound, which may contribute to the noted rear-end crashes.

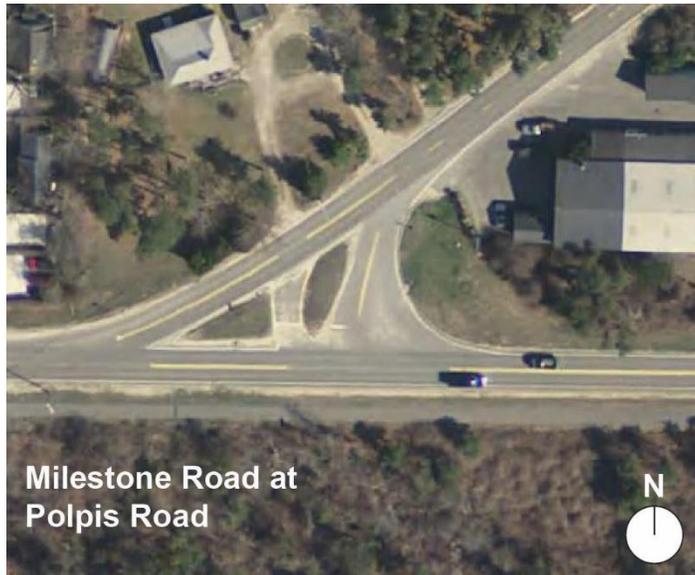
Figure 4: Milestone Road at Polpis Road

- **Milestone Road at Polpis Road:**
The intersection of Milestone Road and Polpis Road (see Figure 4) is a three-way unsignalized intersection with Polpis Road meeting Milestone Road from the north. Polpis Road is a two-way, two-lane roadway owned and maintained by the Town of Nantucket. The southbound Polpis Road approach is stop-controlled where it meets the intersection. Two traffic islands are located on the Polpis Road approach. The two traffic islands provide two lanes divided by an island that allow for left turns from Polpis Road onto Milestone Road,

The audit team discussed that the intersection design is confusing for drivers. Two traffic islands provide three Polpis Road approaches to the intersection, two of which allow channelized, left turn movements onto Milestone Road eastbound. In addition, the two traffic islands require pedestrians to cross Polpis Road three times to get across the intersection. The intersection is stop-controlled on all Polpis Road southbound approaches. A STOP AHEAD sign is provided in advance of the intersection on Polpis Road southbound.

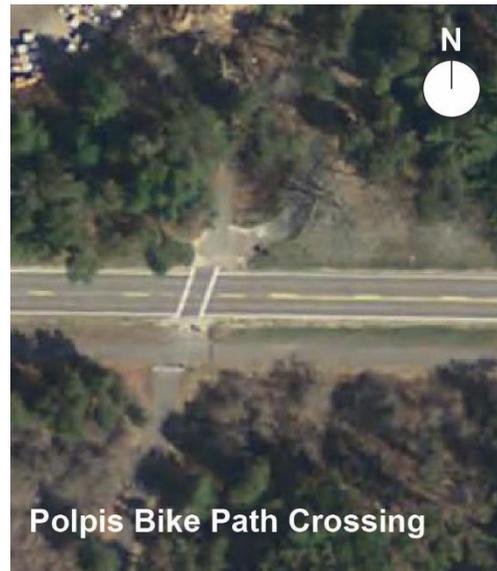
Figure 5: Milestone Road at Polpis Bike Path Crossing

- **Milestone Road at Polpis Bike Path Crossing:** The north/south Polpis Bike Path crosses Milestone Road approximately 500 feet east of the Milestone Road/Polpis Road intersection. The crossing is uncontrolled. Painted warnings are provided on both bike path approaches to the intersection. A standard style crosswalk is provided at the crossing with warning signs.

The audit team noted that the crossing is demarked by longitudinal pavement markings only. In addition, the audit team discussed that the bike path crossing is collocated with a passing zone, creating potentially dangerous situations. Removal of the passing zone at this location was suggested by audit team members.

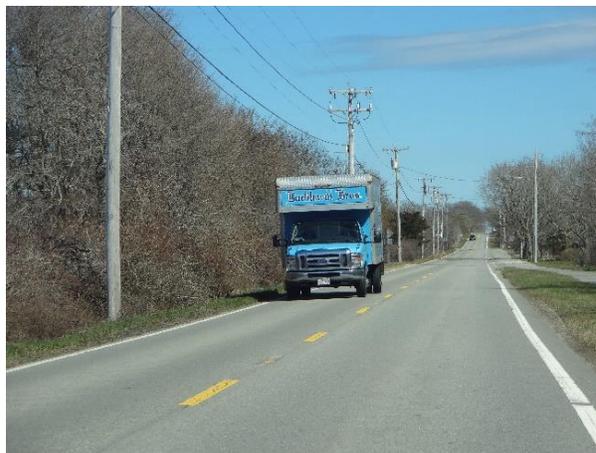
The narrow width of the roadway was noted as a contributing factor to driver discomfort, especially for larger trucks and buses that traverse the corridor. The existing road measures approximately 21 feet between the solid white edge lines on either side of the road, providing a single 10.5-foot lane in each direction. The lack of shoulders on either side of the roadway was also noted as a factor contributing to the perceived narrowness of Milestone Road. Members of the audit team discussed that average daily traffic along the corridor varies widely with the seasons. During the yearly peak, 15,000 to 18,000 vehicles may travel along the corridor each day. Furthermore, the portion of Milestone Road between The Milestone Rotary and New South Road serves as a truck route servicing the industrial area located on New South Road.

Photograph 1: A truck on Milestone Road westbound

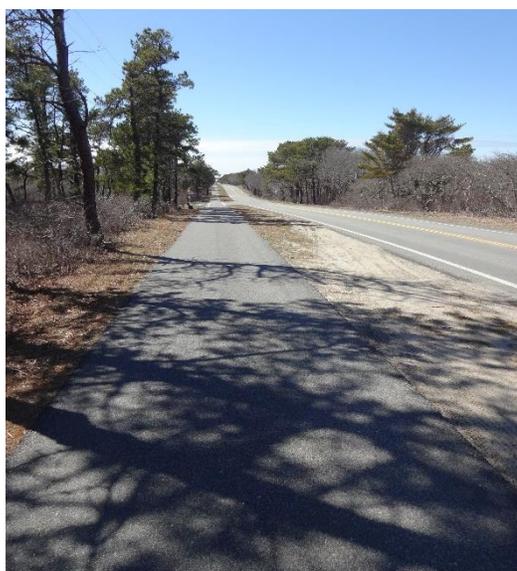
The audit team discussed that while the Sconset Bike Path along the southern side of the corridor provides bicycle and pedestrian accommodations throughout the majority of the corridor, access to and from the path is difficult. Throughout the six-mile corridor, crosswalks across Milestone Road are only provided in two locations (one at New Street and one at the Polpis Bike Path crossing). Neither of these crosswalks are accompanied by pedestrian traffic signals and the audit team noted that the community is strictly against installing traffic signals. The audit team discussed that there are painted STOP markings on the bike path for both the northbound and southbound approaches of the Polpis Bike Path crossing on Milestone Road. However, no posted signs are provided to communicate to bicyclists that they should stop before entering the roadway, as is provided

Photograph 2: Typical condition along the Sconset Bike Path

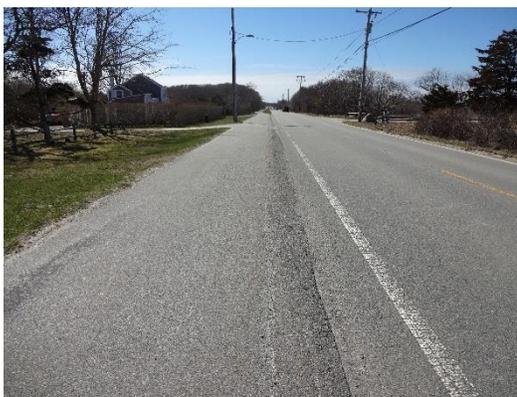
Photograph 3: The Sconset Bike Path becomes a road-side facility with no curb before discontinuing at New Street

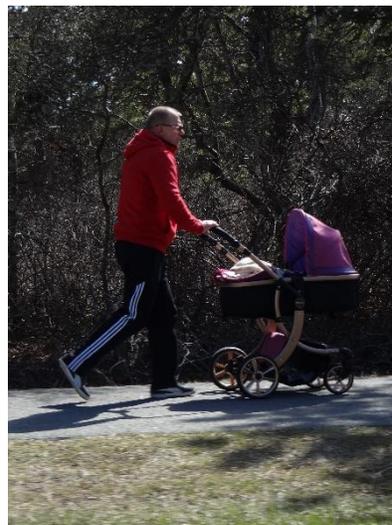
Photograph 4: A pedestrian traveling along the Sconset Bike Path

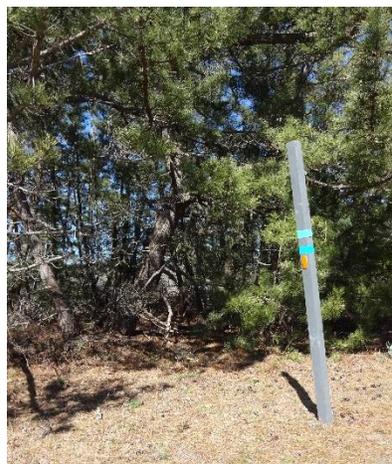
The audit team discussed that the Nantucket Regional Transit Authority operates a seasonal bus service along the corridor between Memorial Day and Labor Day. Bus stops along the corridor are noted with two blue stripes located on traffic poles. Members of the audit team noted that the bus service is well-used during the peak months. However, the team noted that access to and from the bus stops along the corridor is challenging for pedestrians because crosswalks are not provided across Milestone Road. The audit team also discussed that many buses stop in-lane to load and off-load passengers and that motorists sometimes maneuver around the stopped bus to pass in the oncoming traffic lane. Audit team members noted that bus loading and unloading is often a lengthy process because passengers frequently use the bus front-rack to transport bicycles as well.

Photograph 5: A typical bus stop along the corridor

- Install high-visibility crosswalks and associated ADA-compliant ramps across Milestone Road at each bus stop location to improve safety conditions for pedestrians crossing the street to reach bus stops on opposite side of road.

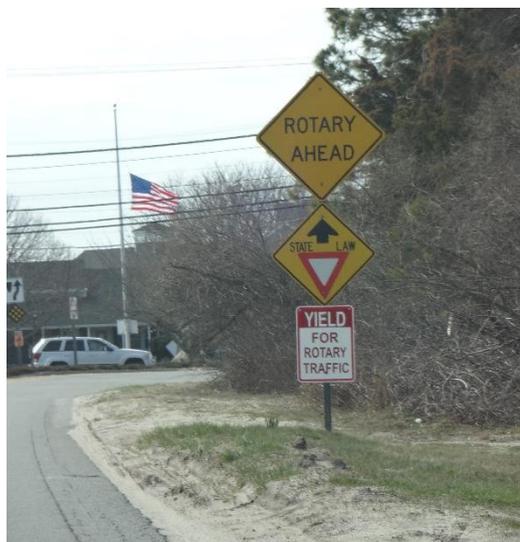
Photograph 6: Signage on the westbound Milestone Road approach to the Milestone Rotary

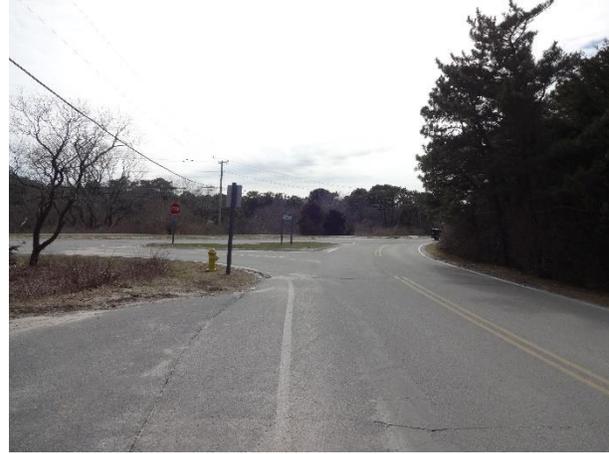
Photograph 7: A y-style intersection is provided at Monomoy Road

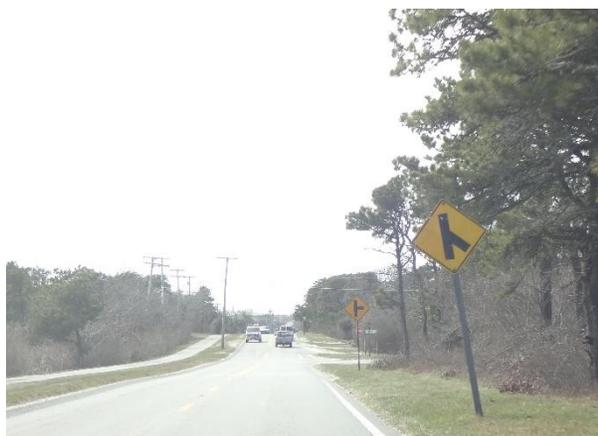
Photograph 8: Confusing signage on the westbound approach to Polpis Road

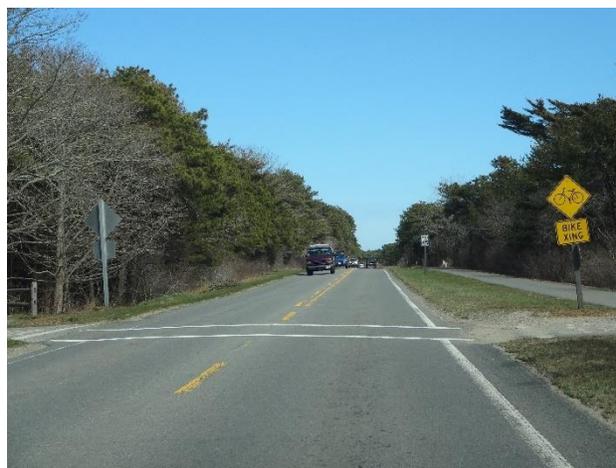
Photograph 9: Existing crosswalk and BIKE XING sign at Polpis Bike Path crossing

- Consider installing actuated control device, such as RRFB, to assist pedestrians and bicyclists in safely crossing Milestone Road.

- Consider additional reflective signage to provide additional cues to drivers about pedestrians and bicyclists crossing Milestone Road.
- Eliminate existing vehicle passing zone within 500 feet of the crosswalk.

- Replace existing standard crosswalk with high-visibility crosswalk.

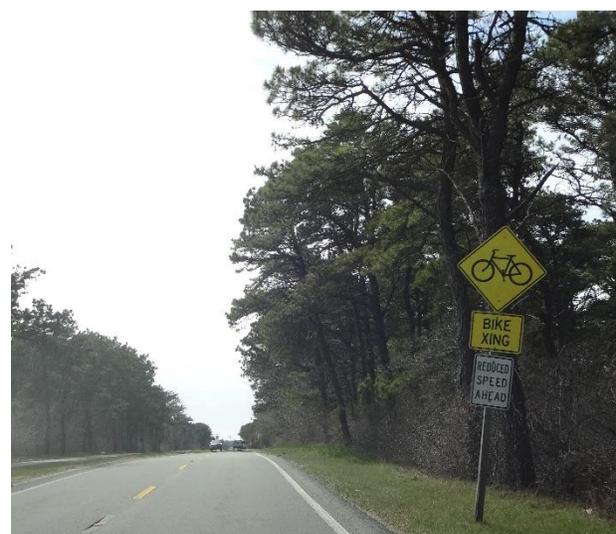
Photograph 10: Advance warning is provided on the approach to the Polpis Bike Path crossing

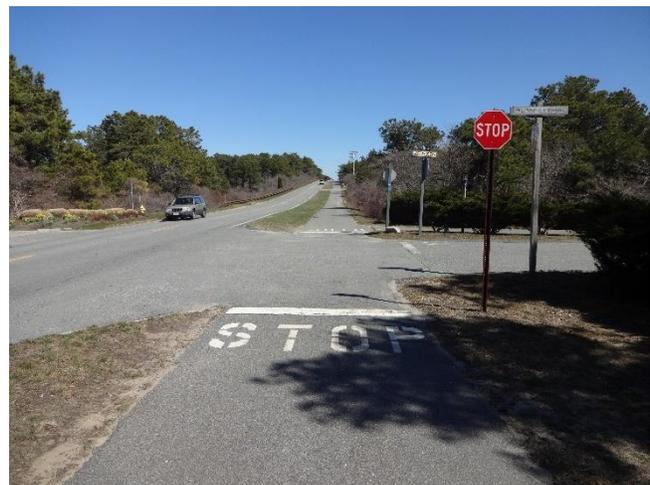
In addition, the audit team noted that the bike path does not have crosswalk markings across Milestone Road.

Photograph 11: Existing Sconset Bike Path conditions at Milestone Crossing

- Replace faded stop line on Milestone Crossing northbound approach.
- Install high-visibility crosswalk across Milestone Crossing and Milestone Road.

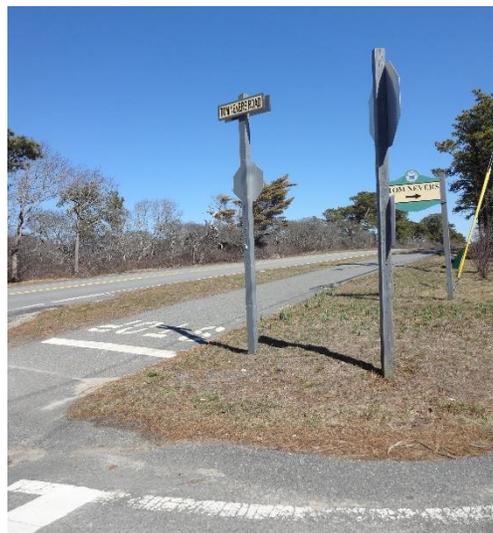
Photograph 12: Poor sight distance looking east at Tom Nevers Road due to hill crest

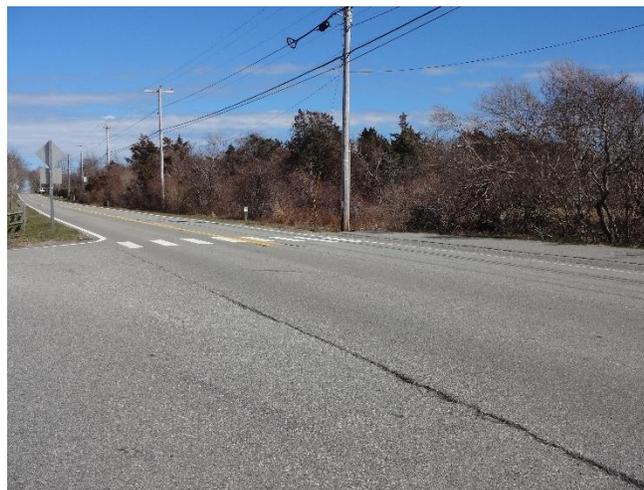
Photograph 13: The Sconset Bike Path is discontinued at New Street

The audit team discussed that the intersection of Milestone Road and New Street is significant for pedestrians and bicyclists because it is the terminus of the Sconset Bike Path. Members of the audit team noted that the crosswalk across the eastern leg of the intersection was added to provide access to and from

- Replace non MUTCD-compliant PED XING signs with compliant pedestrian (W11-2) warning signs at the existing crosswalk and in advance of the crosswalk.

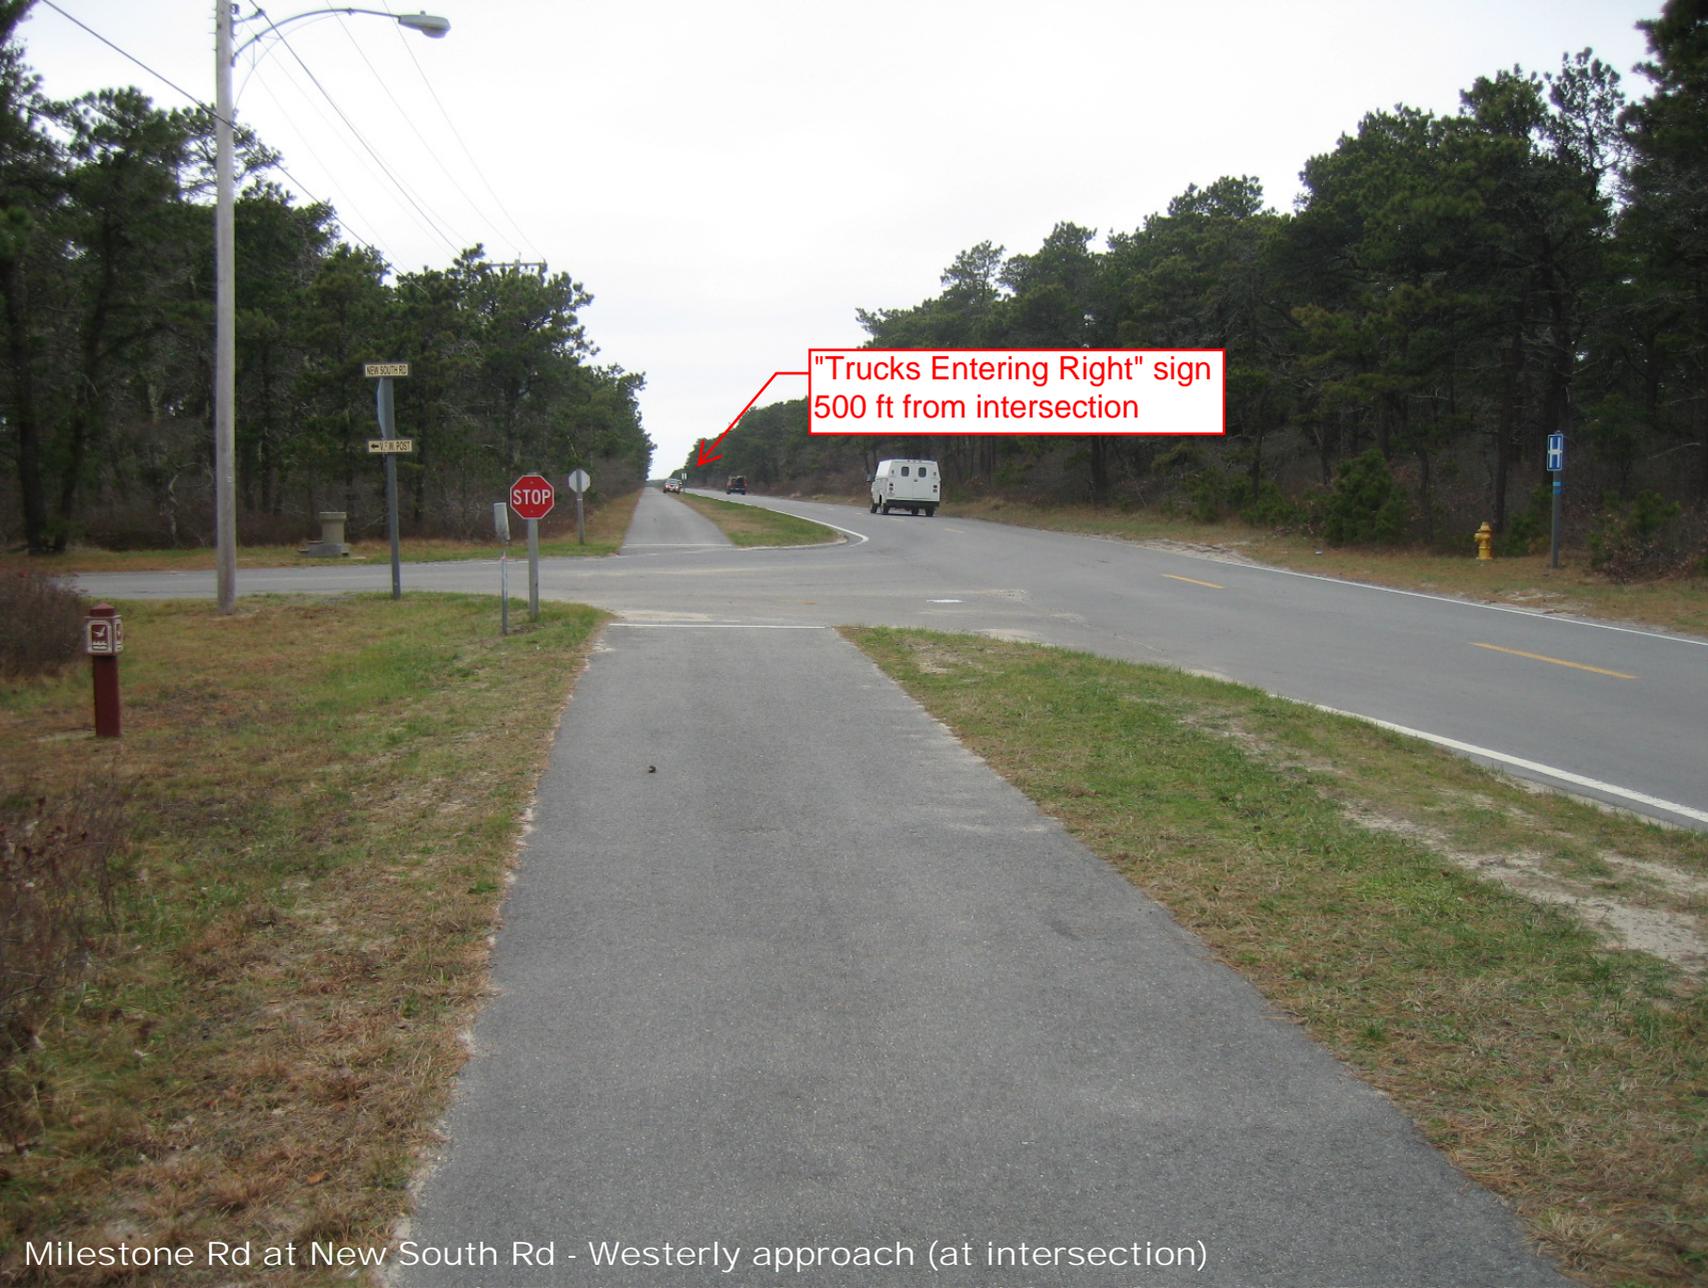
Milestone Rd at New South Rd - Westerly approach (at intersection)

"Trucks Entering Right" sign
500 ft from intersection
