MEMORANDUM

Date: March 23, 2018
To: Emily Molden and Cormac Collier, Nantucket Land Council
From: Trey Ruthven, Matt Doelp, and John Ramsey
Subject: Review of SBPF's Annual Review of Sconset Geotextile Tube Project Report

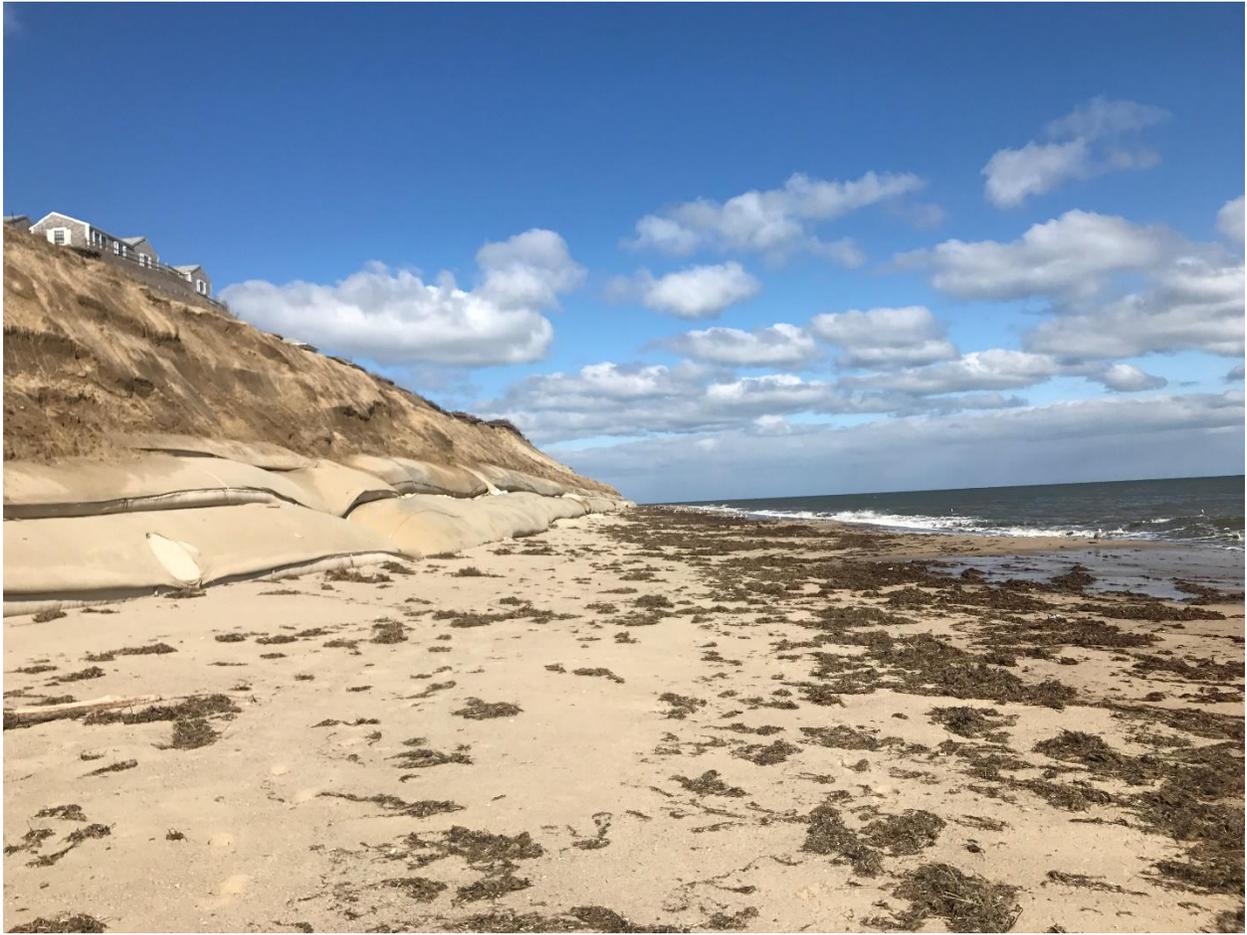
Figure II Image of the exposed geotubes (facing the north) after a March 13th, 2018 Nor'easter. The front of the geotubes are fully exposed.

5. During storm events, a majority of the mitigation volume is inaccessible for transport once the sediment in front of the geotubes has eroded (Figure I). The additional mitigation volume sitting above the geotubes beyond the reach of the active surf zone is inaccessible to the littoral system (Figure II). SBPF recognizes that a portion of the mitigation volume sits above the project and does not include it in their residual volume survey. However, they do not decrease the residual volume by an estimated eroded volume that should have been available to the littoral system if the geotubes were not covering the bank sediments. This volume is important, as the majority of erosion occurs during storms.

- During storm events, exposed geotubes act as hard structures that exacerbate wave energy reflection. The reflection of wave energy induces turbulence and accelerates the erosion of beach in front of the tubes. The exposed tubes also accentuate the movement of water parallel to the tubes, resulting in currents that can scour the project ends (Figure III). It is critical that the face of the structure is continuously supplied with material to mimic the natural function of the coastal bank. The currently designed mitigation delivery system is unable to achieve this during the critical storm and post-storm time periods; therefore, it is recommended that a portion or the entire mitigation volume be placed on the beach

north and south of the geotubes. By placing the material on the beach, the material will be available during storm events to help mitigate the adverse impacts the geotube structure is causing to adjacent shorelines.

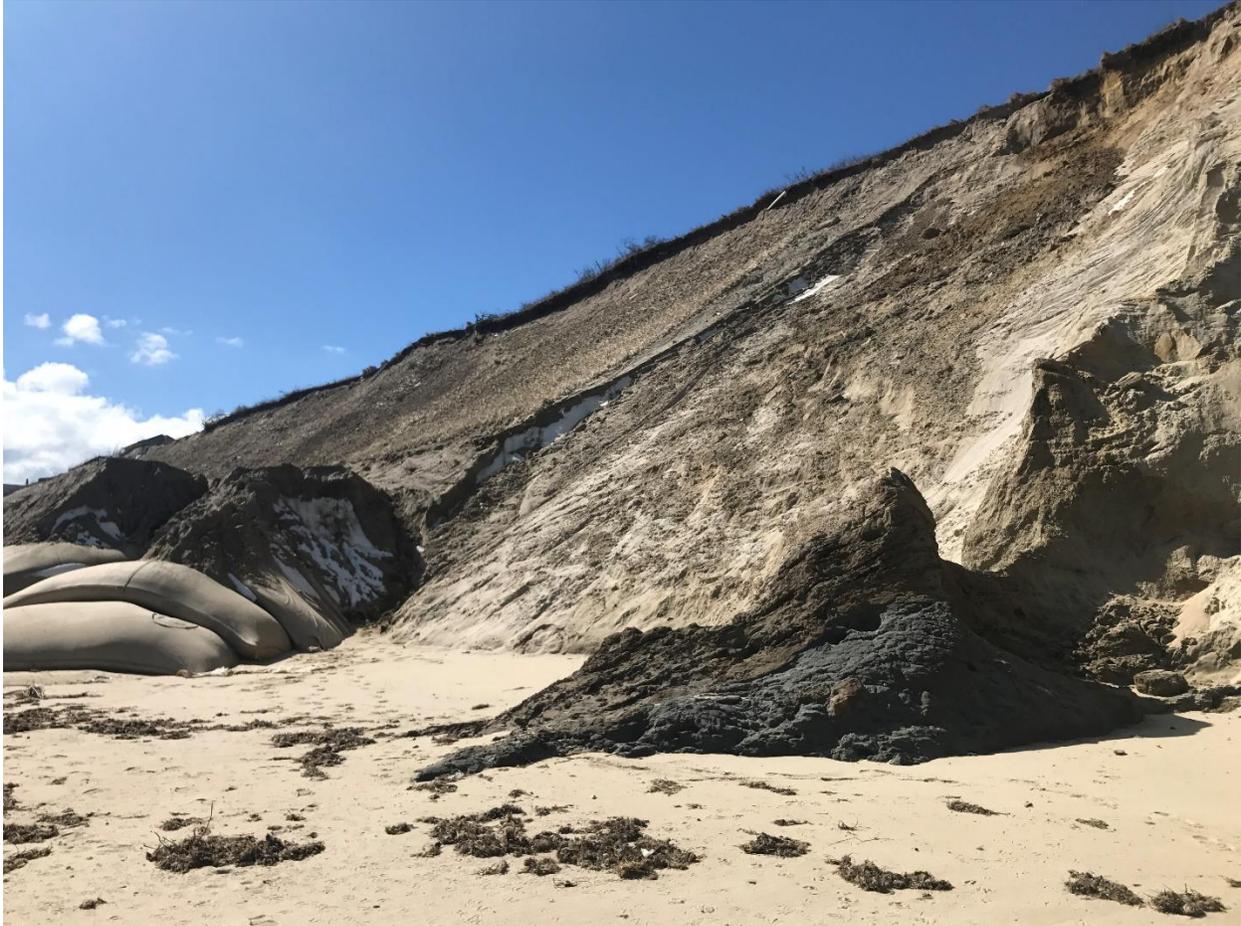
Figure III Image of the north end of the project after a March 13th, 2018 Nor'easter. The front of the geotube are fully exposed with significant erosion at the terminal end. With sand remaining untouched on top of the geotube, the natural longshore transport of sand is interrupted resulting in a starved updrift and down drift beach adjacent to the project. These "end effects" create accelerated erosion of the coastal bank adjacent to the project.

1. Supplying the ends of the projects site with some of the planned mitigation volume to allow for rapid transport north and south of the project site during a storm event in which the tubes are exposed.

4. Require visual inspection and photography of any exposed or scoured regions following minor or major storms to document time periods when mitigation sediments are unavailable. In addition, this documentation would facilitate a better understanding of potential adverse impacts associated with this coastal engineering structure..
