TOWN OF NANTUCKET GREAT PONDS MANAGEMENT PRINCIPLES

Prepared by the Town of Nantucket Natural
Resources Department

August 7, 2019

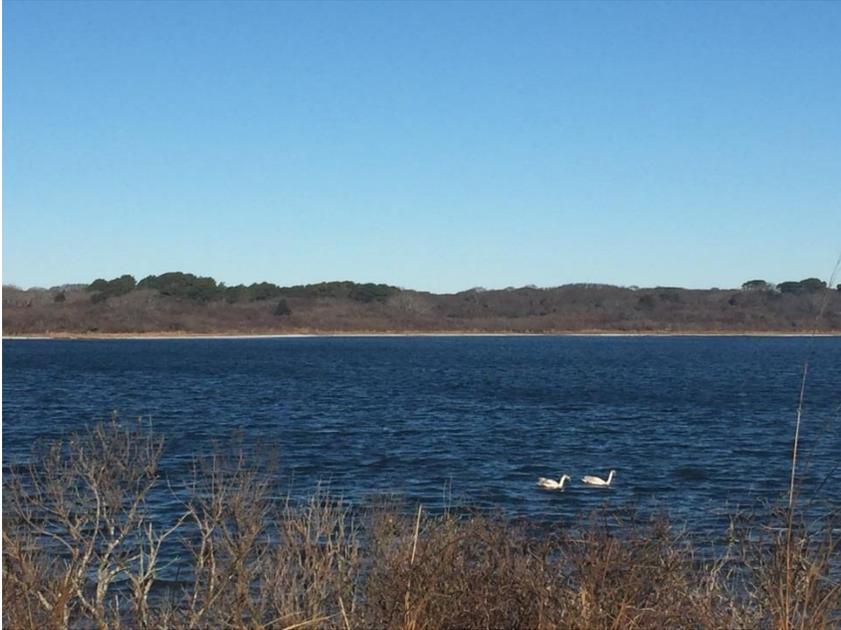
Sesachacha Pond Watershed

Figure 1. Extent of Sesachacha Pond watershed, as determined by Horsley, Witten and Hegeman in 1990 Nantucket Water Resources Management Plan. Location of water quality sites used for Massachusetts Estuaries Project sampling.
