# Sconset Bluff May 2018 Aerial Survey Report

## Baxter Road and Sconset Bluff Stabilization Project Nantucket, MA

September 2018

**Epsilon Associates**  
3 Mill & Main Place, Suite 250  
Maynard, MA 01754

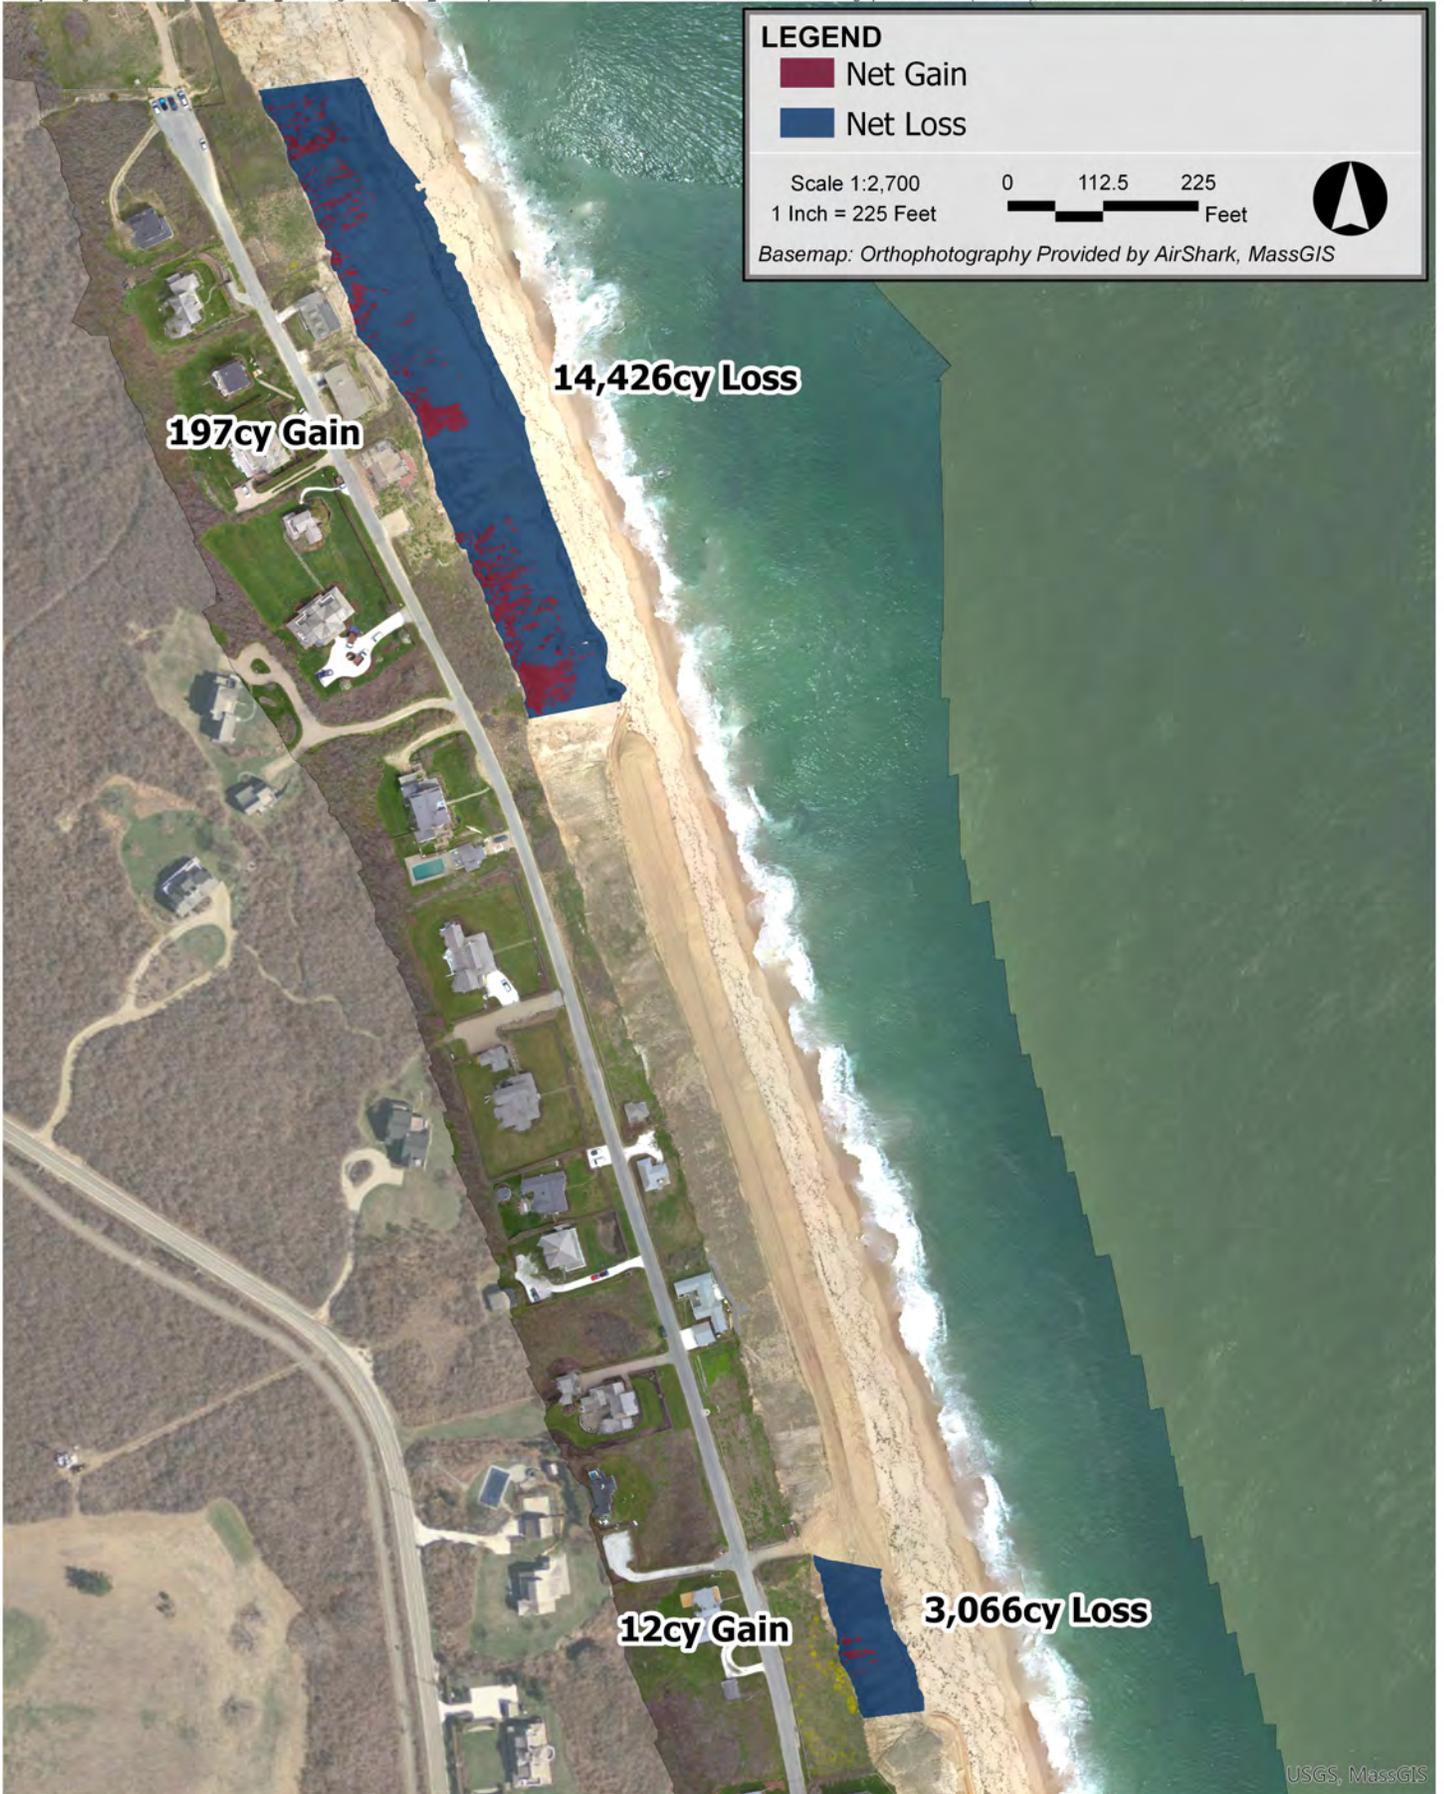
**Baxter Road and Sconset Bluff Storm Damage Prevention Project Nantucket, Massachusetts**

The results of the 2018 aerial survey were used to calculate the changes in the bluff volume from 2017 to 2018 for those unprotected areas immediately adjacent to the geotextile tube project (Figure 1). The change in the bluff volume in these unprotected areas was calculated from the toe of the bluff (elevation + 11 MLW) to the top of the bluff.

- For the north unprotected area, the section of bluff within 802 feet immediately to the north of the geotextile tubes was used.
- For the south unprotected area, the section on bluff within 192 feet immediately to the south of the geotextile tubes was used. Areas farther south than this could not be used because they had coir or jute terraces installed and so were not representative of the unprotected bluff.
- No areas with a bulge of sand from sand delivery activities at the accessway between 85 and 87 Baxter Road were used in the calculations.
