Re: NOI, Baxter Road and Sconset Bluff Storm Damage Prevention Project

MEMORANDUM

Date: July 29, 2013
To: Emily MacKinnon and Cormac Collier, Nantucket Land Council
From: John Ramsey, P.E. and Trey Ruthven
Subject: Baxter Road and Sconset Bluff Storm Damage Prevention Project

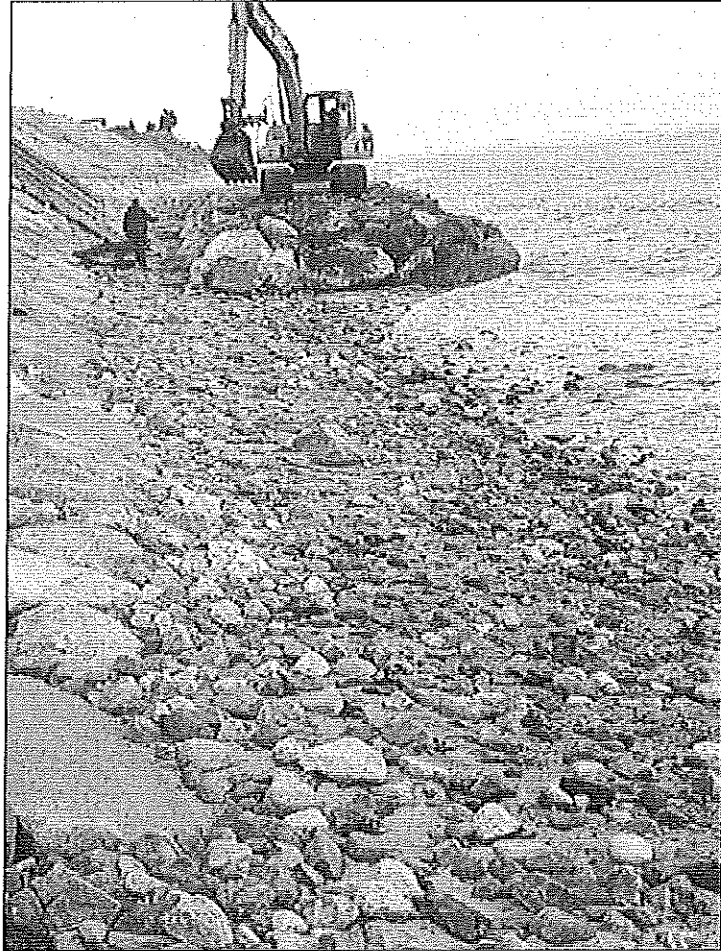
Figure 1: Photograph from letter written by Robert Hamilton (VP of Business Development) and Tara Marden (Coastal Geologist) of Woods Hole Group, Inc. regarding 2007 reconstruction of revetments along Triton Way in Mashpee. Note the lack of beach fronting the structure and the need to construct a work platform at the base of the revetment to allow reconstruction (*source: Mashop Village Trust website*).

revetments have been constructed in Massachusetts, but does not provide any documented evidence of revetments in similar erosional environments. For example, the Triton Way revetments are in an area with long-term erosion rates of less than 1 ft/yr and as demonstrated, the areas fronted by revetments no longer have a high tide beach.

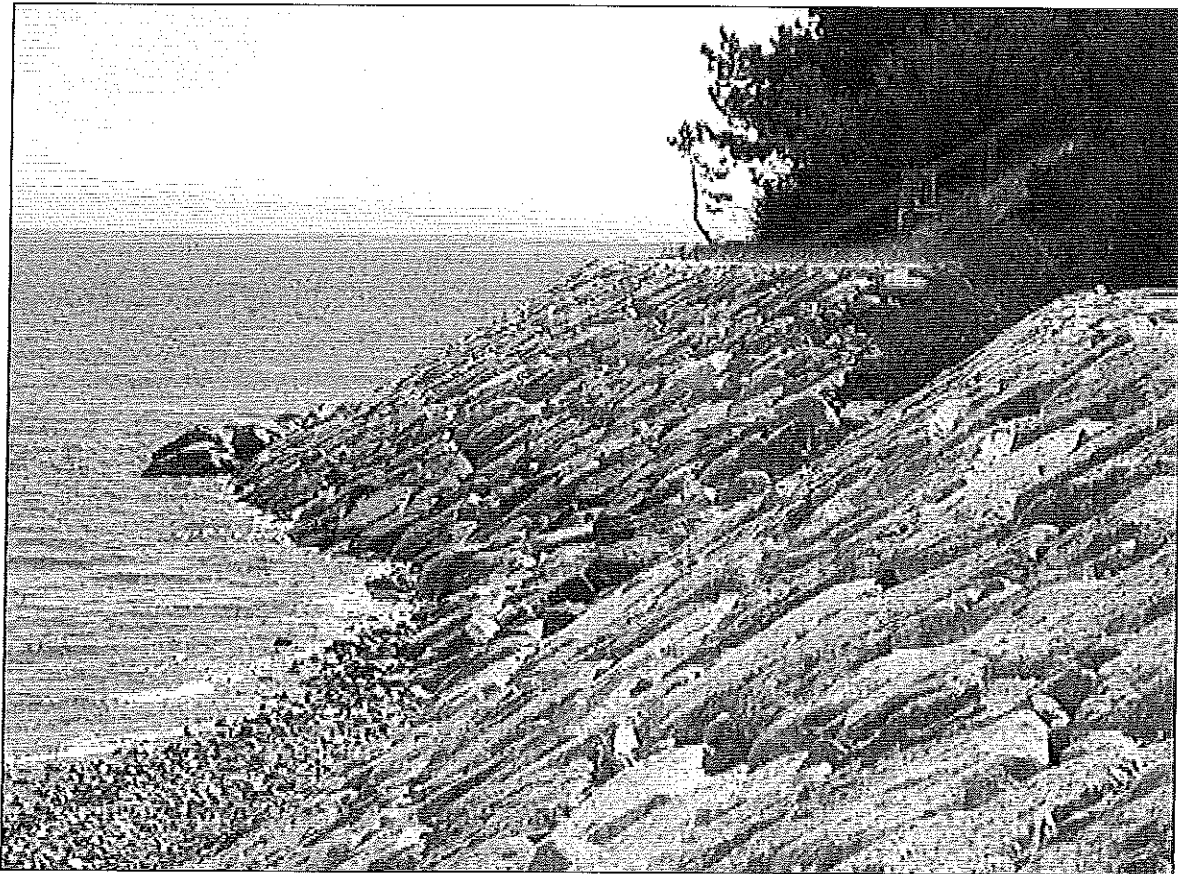
Figure 2: View of completed Triton Way revetment reconstruction that occurred during the 2006/2007 winter season (*source: Woods Hole Group, Inc. website*).
