Nantucket Memorial Airport Master Plan Update

Chapter 6– Facility Requirements

2015

Jacobs Engineering

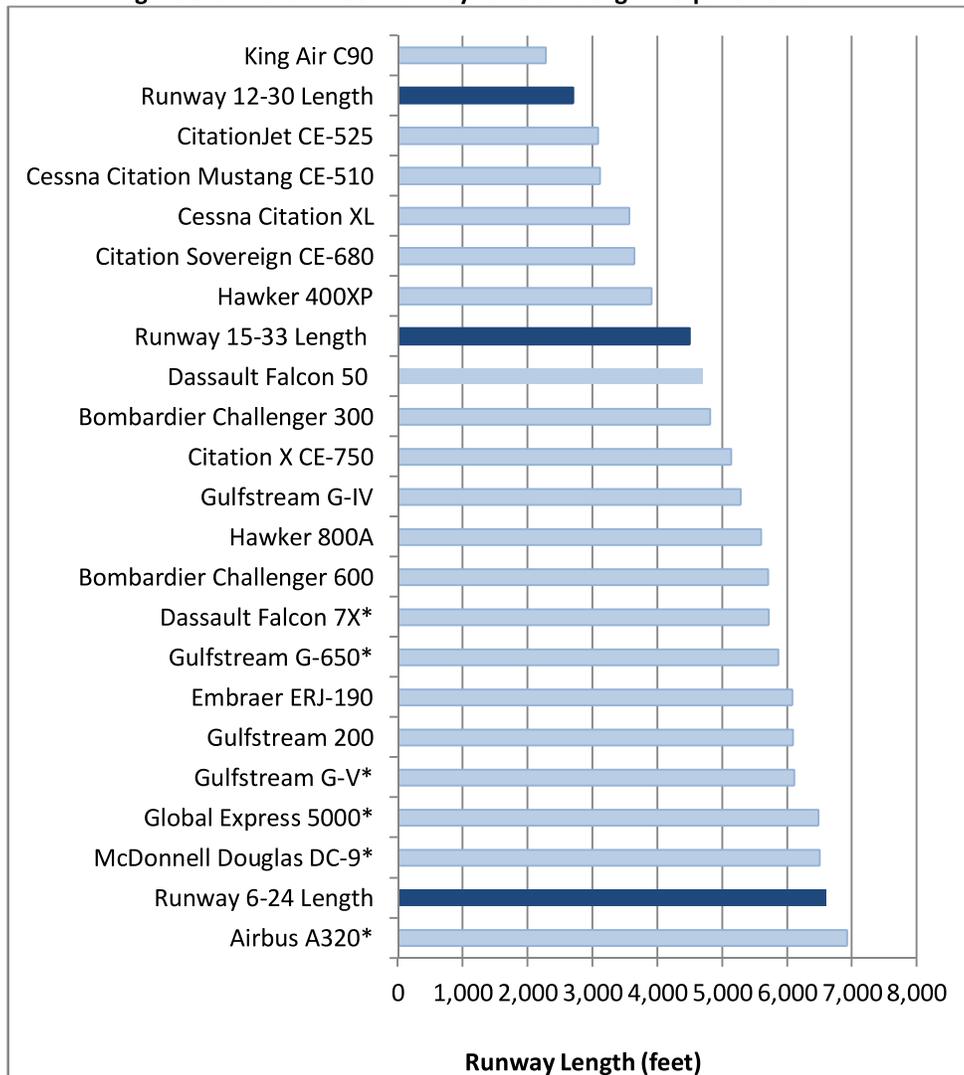
Figure 6-1 Aircraft Fleet Runway Take Off Length Requirements ¹³¹⁴¹⁵

*Indicates aircraft weighing 60,000 lbs. or greater.

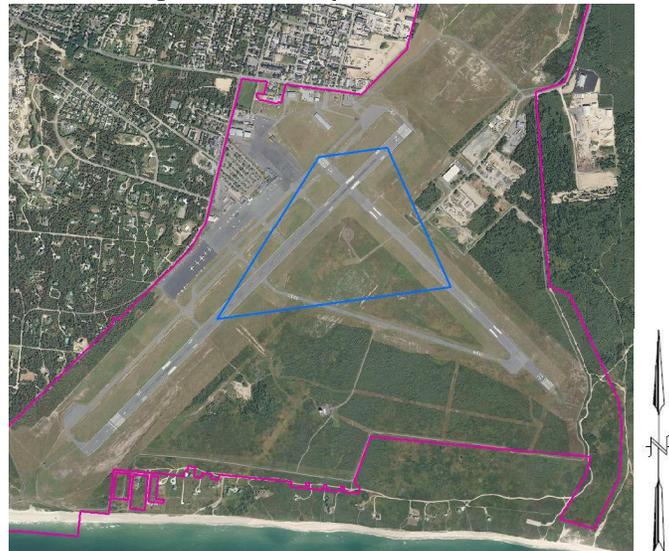
Figure 6-2 Runway Visual Zone at ACK

All runway line of sight standards are met between Nantucket's intersecting runways.

The air traffic controllers at ACK have indicated that there is poor visibility from the ATCT (Air Traffic Control Tower) to the Runway 33 threshold. They also stated that the terminal building roof partially blocks their view of an aircraft parked on the secure side of the North Ramp. The FAA has completed a separate Control Tower siting process which determined that the ATCT will remain in its present location and at its present height.

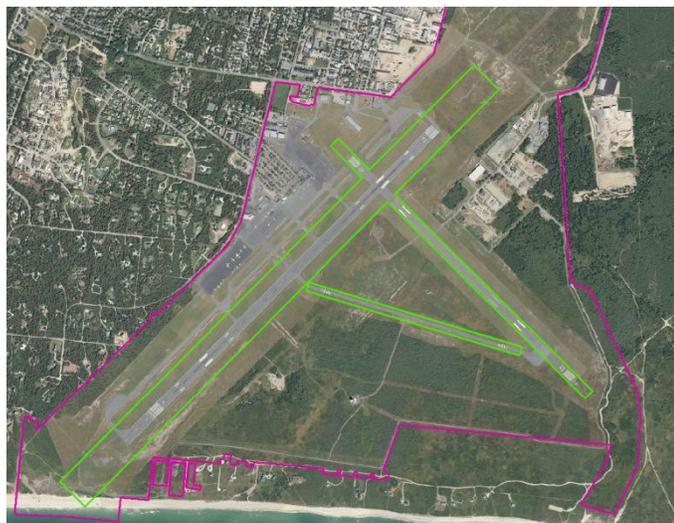
Figure 6-3 Runway Safety Areas at ACK

Shown in **Figure 6-3** below is an image of the existing RSAs at ACK, depicted in green. Note that all RSA's are within the airfield property, with the exception of the Runway 6 RSA, which extends out over Nobadeer Beach. The Runway 6 RSA centerline length is 950 feet. However the RSA's southerly side has a length of 787 feet from the end of the runway to the airport security fence, located on the backside of the coastal dune. Since the FAA Safety Standard is a full 1,000 feet, the south edge of the RSA has a deficiency of 213 feet. This creates a non-standard safety condition for an aircraft overrun or undershoot on the Runway 6 end.

The Runway 6 RSA does not meet the full FAA standard for RSA dimensions. However, the FAA issued a Runway Safety Area Determination, dated 9/31/2000 (see [Appendix 4](#)), which found that extending the RSA was impractical and the costs of shifting or shortening the runway, or adding EMAS, were not justified for the small deficiency that exists. The Airport completed an RSA Study dated January 31, 2002, which verified that the existing irregularly-shaped RSA was of the maximum practicable area, per FAA Order 5200.8 and confirmed the FAA’s previous determination. Concerns with erosion of Nobadeer Beach were discussed in Chapter 3 “Environmental Overview” and mitigation options are reviewed in Chapter 7. The Runway 12-30 RSA width (60’ from centerline) was field checked and the grading was determined to be in compliance with FAA Standards (Table 6-3). This updates the finding in Appendix B, relative to filling to grade on both sides of the runway, which is not needed.

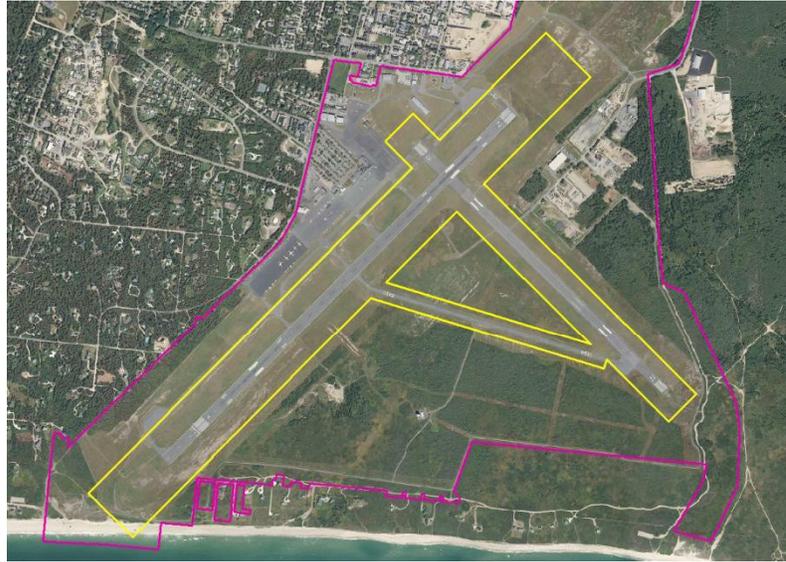
Figure 6-4 Runway Object Free Areas at ACK

All runway ROFA FAA design requirements are met.

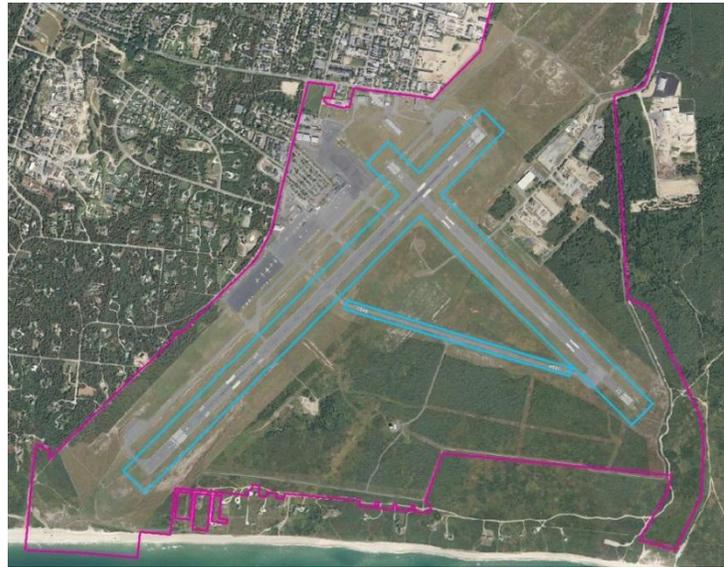
Figure 6-5 Runway Obstacle Free Zones at ACK

The ROFZ is a defined volume of airspace centered above the runway which supports the transition between ground and airborne operations. All ROFZs extend 200 feet beyond each end of the runway and the size of the ROFZ is based on aircraft approach speed and the visibility minimums to the runway end. **Table 6-5** lists the ROFZ standards vs. existing conditions. **Figure 6-5** on the following page provides an image of the existing ROFZs at ACK, delineated in blue.

Based upon examination of the FAA standards, all ROFZ requirements are met.

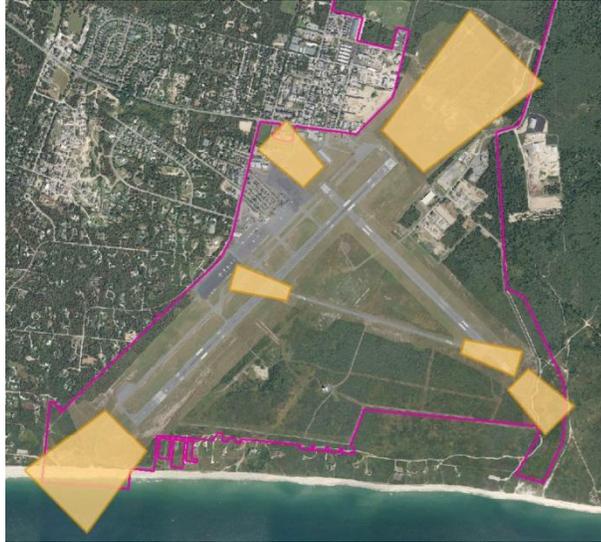
Figure 6-6 Runway Protection Zones at ACK

The RPZ is an area on the ground used to enhance the protection of people and property near the runway approach. In order to ensure that the RPZ's are kept clear of incompatible objects and activities, the land included in the RPZ should be owned by the airport or protected through an aviation easement. **Table 6-6** provides a comparison of RPZ design standards to existing conditions. **Figure 6-6** on the following page illustrates the existing RPZs at ACK, as light yellow trapezoids.

AC 150/5300-13A recommends that RPZs be maintained clear of residences and places of public assembly, including churches, schools, hospitals, office buildings, shopping centers and other uses with similar concentrations of persons. Details of parcels requiring aviation easements or rezoning options will be discussed in Chapter 7.

There are currently 1.7 acres within the RW 15 RPZ that are not fully owned by the airport. This can be corrected by the airport obtaining an aviation easement or enacting a zoning overlay district to control land uses within the RPZ parcels.

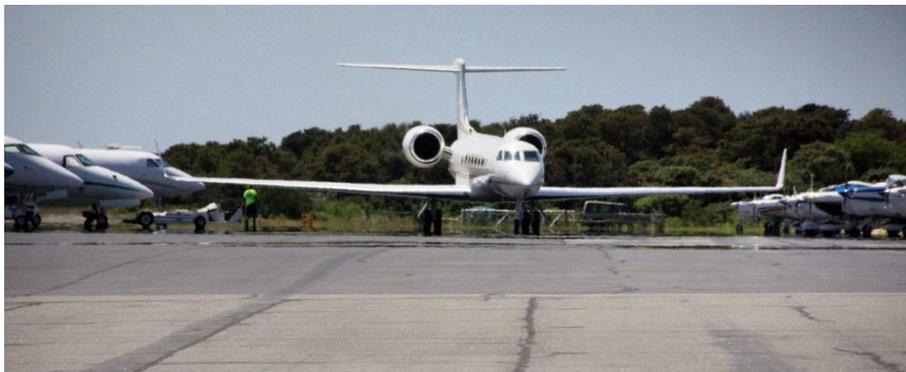
Figure 6-7 Existing South Apron Taxilane Wingspan Constraints for Current GA Jet Fleet

Taxilane clearance and separation standards are based upon the wingspans of the Airplane Design Groups (ADGs), as specified in AC 150-5300-13A, Section 404.a.(4), and Table 4-1. The standards set minimum Taxilane Object Free Area (TOFA) widths based upon safe wingtip clearances for each ADG. Section 404.b.(1) states that Taxilane OFA clearing standards prohibit parked aircraft or other objects within the OFA. The wingtip clearances on the South Apron are very constrained and create operational safety hazards, as shown below in **Figure 6-7**. Nantucket's South Apron was originally designed for smaller aircraft with 54' wingspans. That size wingspan falls into ADG II, which requires a wingtip clearance of 18 feet. The increase in size of corporate aircraft, particularly new modern jets with larger wingspans, has impacted the limited apron space at ACK. The increasing wingspan of modern jet aircraft has reached 99 feet, which places them in ADG III, which require a 27-foot wingtip clearance. The two Taxilanes on the South Apron, while designed to ADG II Standards, are now used by ADG III aircraft, creating a safety hazard. The existing Taxilane OFA's are of insufficient width to safely accommodate these larger aircraft and need to be upgraded to meet the FAA Taxilane Design Standard.

Options for addressing the Taxilane Design Deficiencies on the South Apron will be discussed in Chapter 7. The phasing of this project should be considered in Chapter 8 in conjunction with other airside improvements, such as taxiways, which could improve the arrival rate of aircraft needing to utilize the apron.

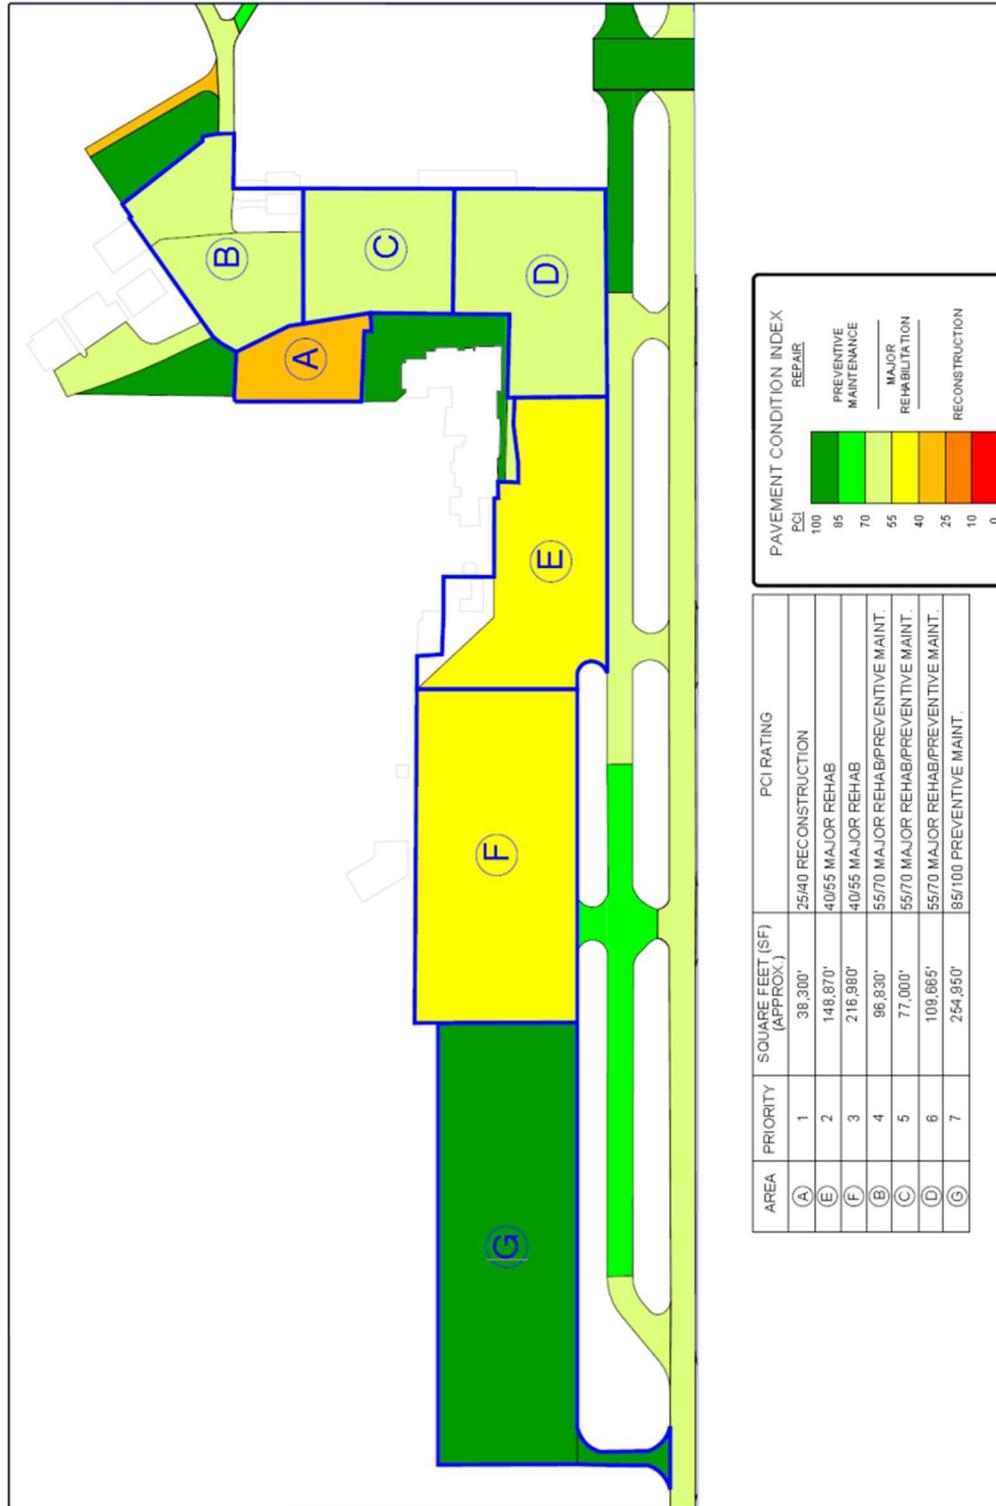
Figure 6-9 Apron Pavement Condition Index ²⁴

The pavement conditions of the various sections of Nantucket’s aircraft parking aprons are depicted on **Figure 6-9** on the following page and **Table 6-9**, below. These terminal apron sections are identified as Areas A through G and most areas are close to, or beyond the end of their 20-year design life. The MassDOT PCI index puts most in conditions requiring “major rehabilitation”. Based upon the age and condition of each area, a Rehabilitation Priority number has been assigned to assist in considering future options. MassDOT’s 2014 Apron Crack Seal project has improved the pavement condition of all of Nantucket’s aprons and extended their life five years beyond the 20 Year FAA Design Life listed under the Rehab Year. The revised Rehab Year should be reviewed with FAA and MassDOT Aeronautics staff.

²⁴ Graphic modified from Hoyer, Tanner & Associates, Inc. *Pavement Condition Index Map* for Massachusetts Department of Transportation-Aeronautics Division, January 2013. This does NOT include 2014 MassDOT Crack Seal improvements which extend pavement life 5-7 years.

Table 6-9 Apron Pavement Condition					
Apron Pavement Area ²²	Pavement Condition Index ²³	Year Last Improved ¹³	Condition Rating ¹³	Next Rehab Year*	Rehab Priority Number
Area A	25-40	1982	Poor	2002	1
Area B	55-70	1993	Good	2013	2
Area C	55-70	1993	Good	2013	5
Area D	55-70	1992	Good	2012	4
Area E	40-55	1979	Fair	1999	6
Area F	40-55	1979	Fair	1999	3
Area G	85-100	1998	Good	2018	7

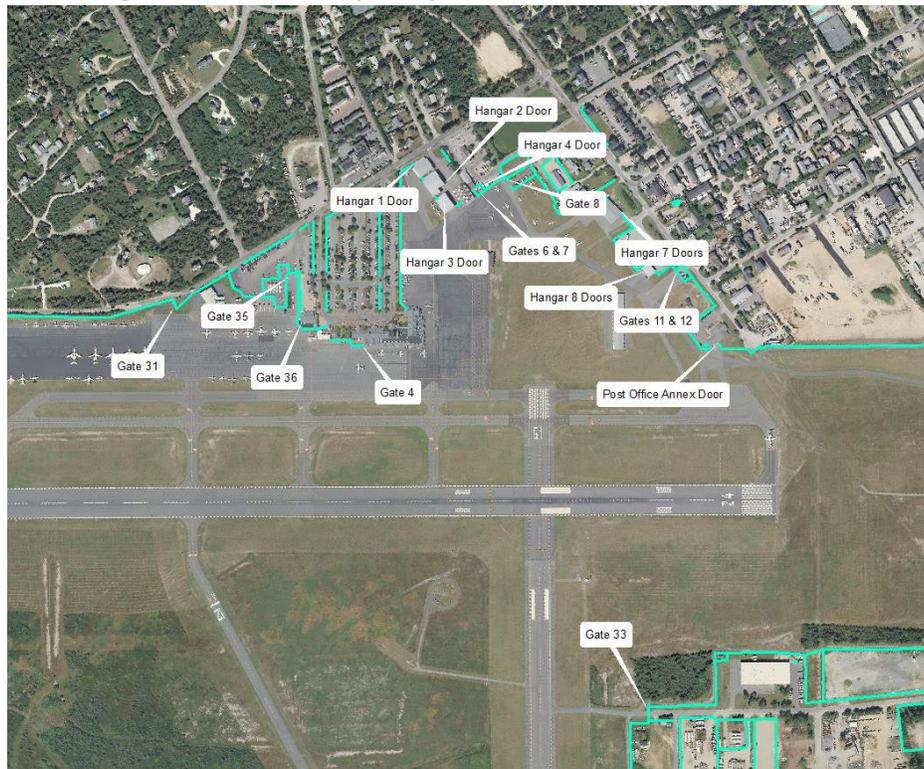
Figure 6-10 Most Frequently Utilized Airfield Access Points

Actuated vehicular gates are controlled by means of a simple control system and reader interface. This interface consists of a security card reader and local control panel connected to a mechanical gate opener. While this system provides basic functionality from a security standpoint, it lacks most of the important elements of an effective electronic security system. Security transactions are only stored locally, at the controller, and alarm events and alert conditions have no means of transmission to the central security office. Further, these local systems are not compatible with the central security system installed in the main terminal, Administration Building and ARFF. This requires security personnel to manually update system parameters by traveling to each actuated gate with a laptop and connection cable. Card holder information, access rights and authentication conditions, among other critical security criteria, are duplicated at each gate rather than stored and backed up in a central database and instantaneous updates to the security databases are impossible. Users and tenants also need to carry multiple access cards for each system. This coupled with the gates and doors that are physically key locked, provide a continuing challenge to maintain positive key and access control. **Figure 6-10** below, shows the most frequently utilized airfield access points.

In 2014, the Airport received an FAA Grant to improve security systems in the main terminal and along the flight line. As part of this project, Gate 6 (a pedestrian gate) and Gate 8 (a vehicular gate) will be upgraded to include new card readers, controls and wireless communications systems to link them with the central security system in the main terminal. This will give ACK security personnel the ability to monitor, change and log the status of these two gates, just as they would with SIDA and other secure doors in the terminal. System users will only need to use their existing security badges for authentication and access.

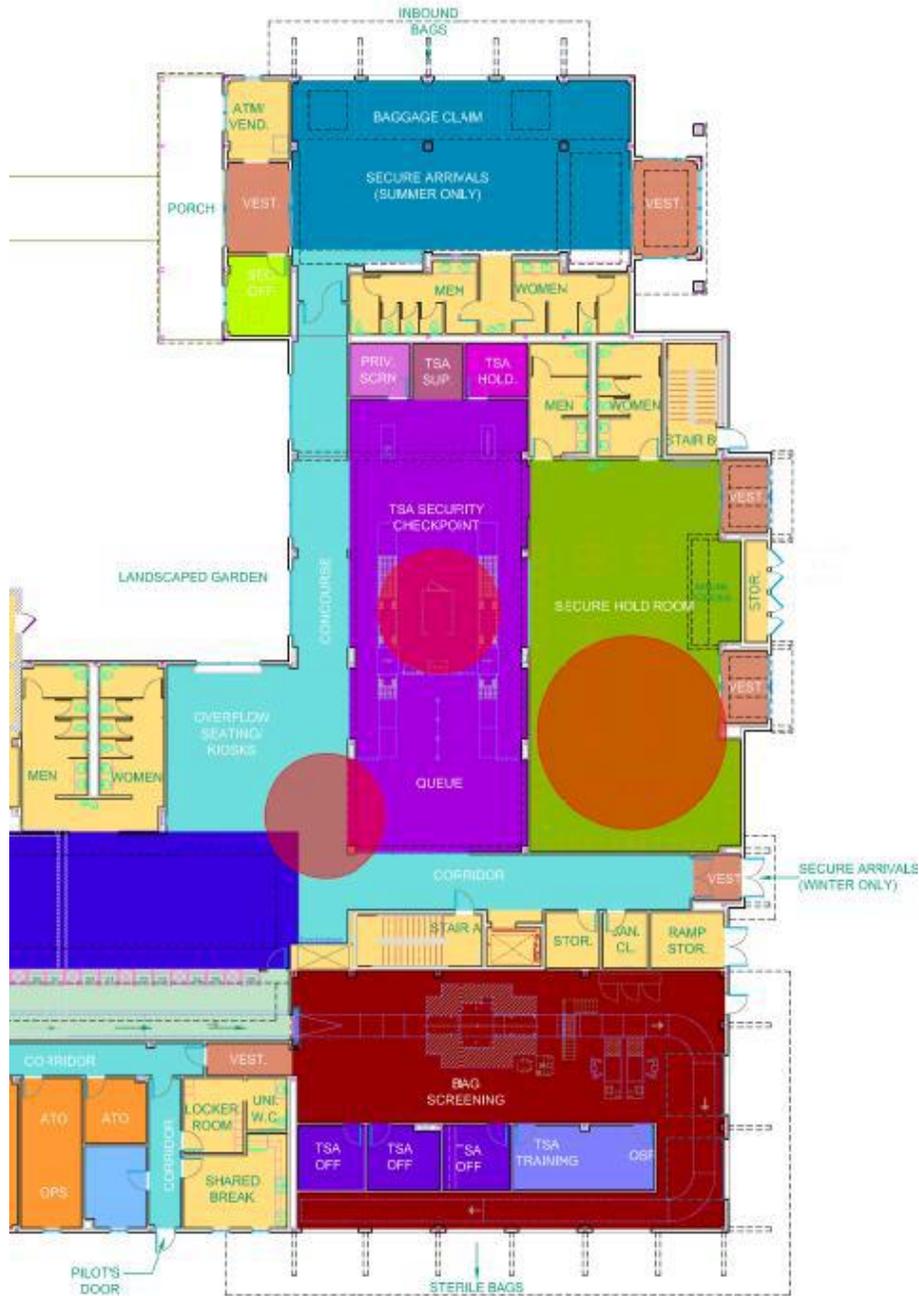
Figure 6-11 Terminal Hold Room “Hot Spots”

Chapter 2.6.2.4 noted that the 2009 Terminal Building renovation included an 18,000 SF expansion to keep pace with then current passenger enplanements, as well as new TSA requirements and airline needs. Adequate space, however, was not provided to accommodate any increases in passenger enplanements through the secure terminal facilities, such as the passenger Hold Room. The current Secure Hold Room is sized at 1,937 SF and rated, per Code, for occupancy by 126 passengers. If the airport is experiencing any delays in service due to inclement weather, or from Air Traffic ground stops on departures, a delay of just 30 minutes has the potential to queue up passengers undergoing TSA screening and overload the secure passenger Hold Room (see **Figure 6-11**, Terminal Hold Room "Hot Spots"), and **Appendix A** – Terminal Building LOS Study.

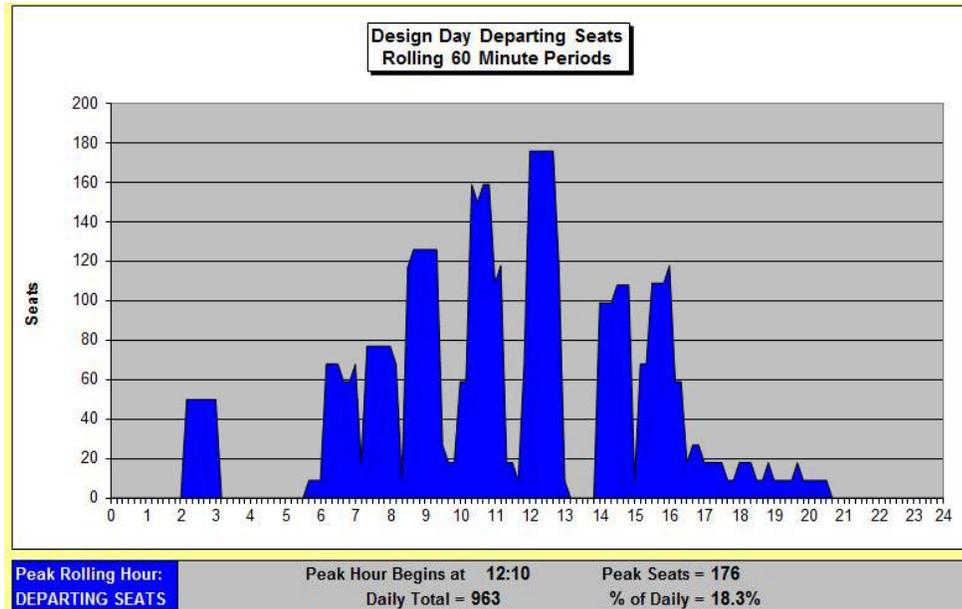
Figure 6-12 – Peak Hour Departing Enplanements

During the peak hour from Noon to 1PM there are 176 departing passengers, assuming 90% load factors on the current fleet during that peak hour (Two ERJ-135’s and one E-190). As noted above, the rated capacity of the Hold Room is 126 passengers. Assuming a Level of Service (LOS) “C”, with 80% sitting (at 15 SF) and 20% standing (at 10 SF), there is a need for 2,464 SF in the Hold Room, versus the 1,937 SF available. At LOS ‘C’, this yields a deficit of 527 SF. To provide LOS ‘A’ service requires 17 SF per sitting passenger and 12 SF per standing, requiring a total of 2,816 SF, or an additional 879 SF (see **Table 6-10**). The existing 1,937 SF Hold Room currently provides LOS “F”.

Even without flight delays, during the peak daily period from 10AM to 1PM the airlines’ normal flight schedules can overtax the seating capacity of the current Hold Room. **Figure 6-12** illustrates the number of airline departure seats during a typical Design Day, based upon Nantucket’s current airline schedule.

Level of Service	LOS “F”	LOS “C”	LOS “A”
SF Requirements	1,937 SF (existing)	2,464 SF	2,816 SF
Current Deficiency	(N/A)	-527 SF	-879 SF
